دفتر بررسی سوانح و حوادث هوایی

بررسی سانحه پرواز PS752

گزارش نهایی

شماره پرونده:	A981018URPSR
نوع رویداد:	سانحه
تاریخ رخداد:	۱۳۹۸/۱۰/۱۸
محل رخداد:	جمهوری اسلامی ایران- نزدیک فرودگاه بین‌المللی امام خمینی (ره) (OIIE)
نوع هواپیما:	بوئینگ ۷۳۷ سری ۸۰۰
علامت ثبت:	UR-PSR
تاریخ صدور:	۱۳۹۹/۱۲/۲۵

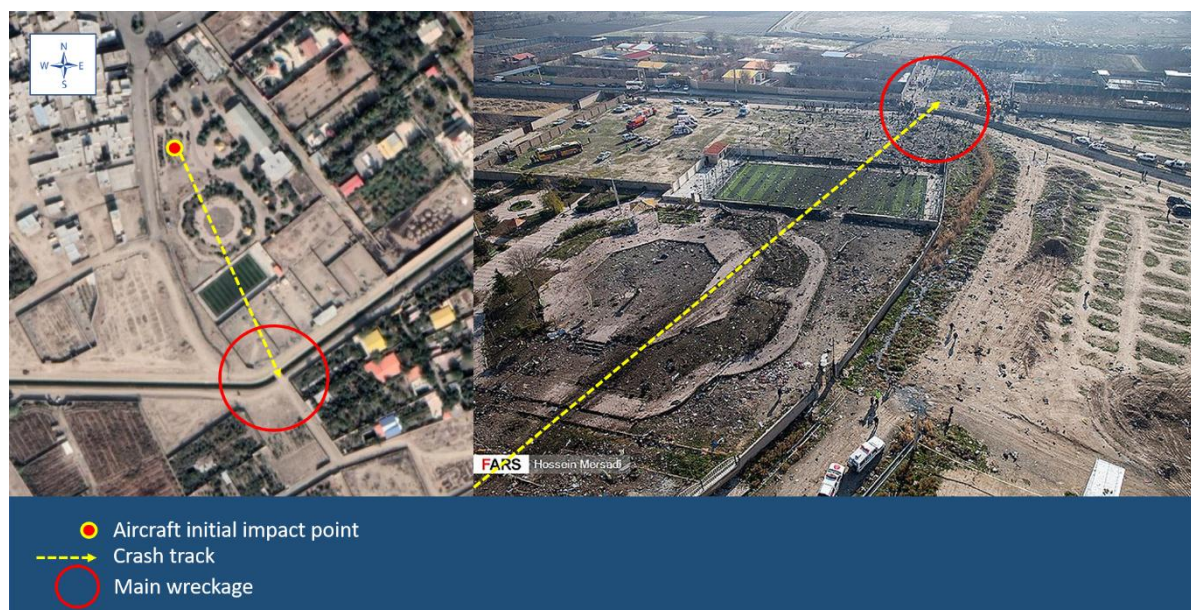
After losing altitude and passing by a residential area, called Khalajabad, the aircraft initial impact point was with a gazebo in a recreational park, called Lale. The aircraft fuselage, subsequently, impacted the ground, disintegrating completely after passing a football pitch, which in turn damaged the surrounding agricultural farms and gardens. Following the initial impact, other impacts were observed along the track at the accident site, wrecking the fuselage and spreading across the entire track. (Figure 3)

Figure 3- Accident site scheme

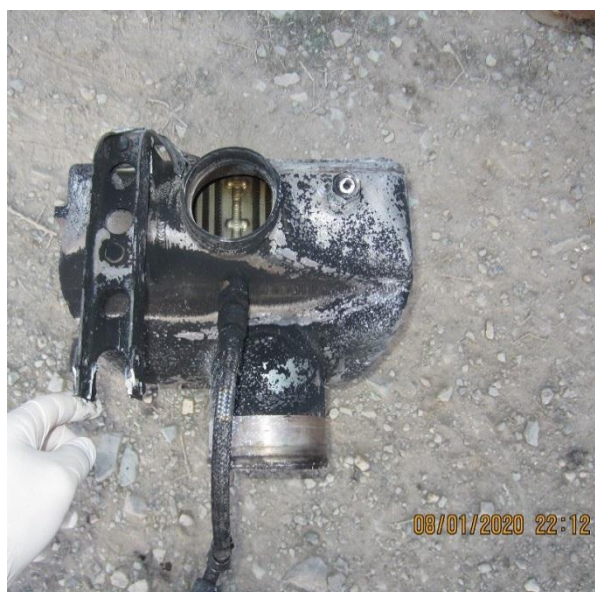
Figure 10- A part of air conditioner found on ground before crash site

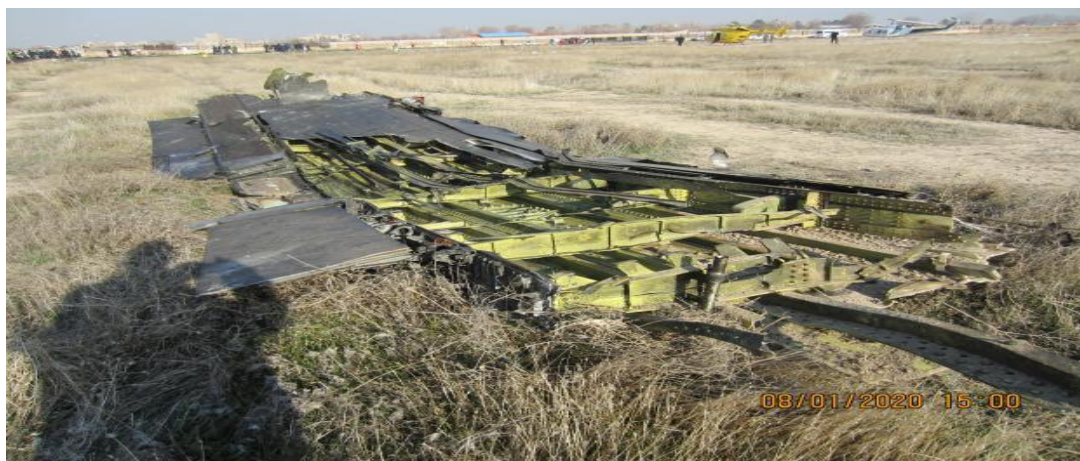
The outer skin of the left wing had signs of burning. There was no sign of fire at the place where the piece was found and the vegetation surrounding

it was undamaged. This showed the burn on the wing had occurred before the crash into the ground. The inner walls of the wing indicated that the fire had not broken out into the aircraft fuel tank. (Figure 11)

Figure 11- The aircraft left wing at the crash site

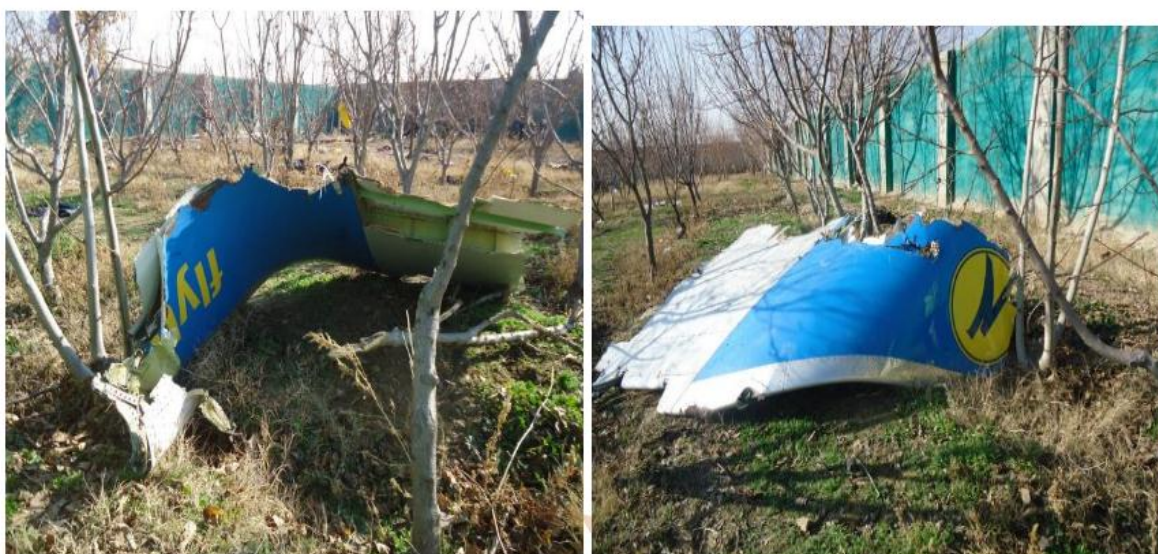
Some parts of the right wing together with the winglet indicated that the fire had not broken out into the right side of it (Figure 12).

Figure 12- The aircraft right winglet

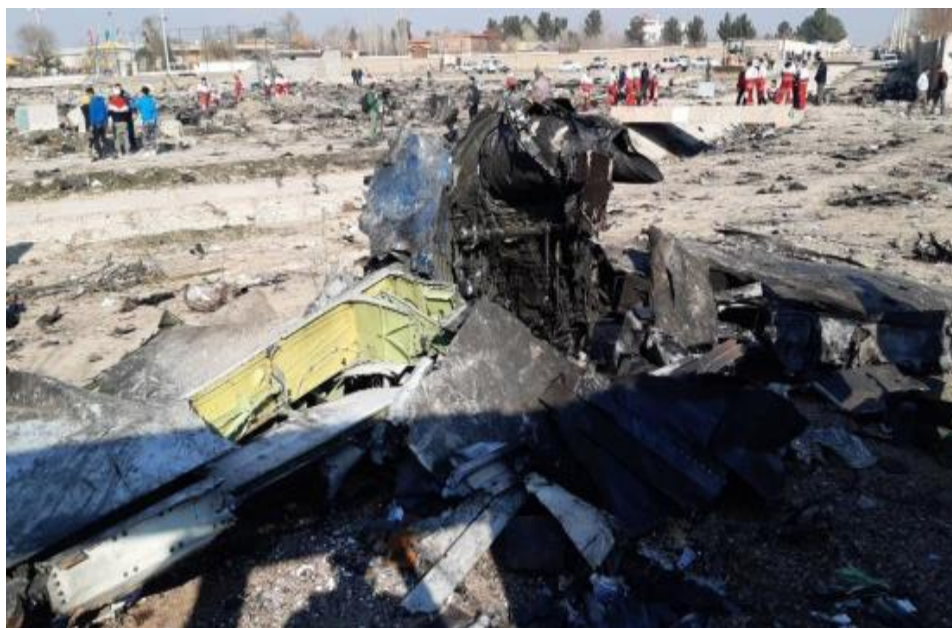
Smoke and burn were observed on the ground close to the Auxiliary Power Unit (APU) (Figure 13).

Figure 13- Auxiliary Power Unit

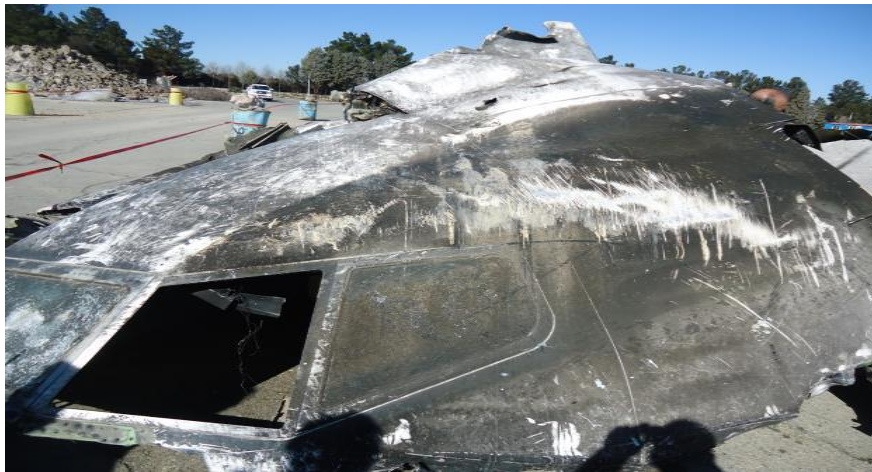
The traces of fire and smoke on the cockpit outer skin mark two situations: before and after the ground impact. In fact, it revealed that the fuselage had caught fire before the ground impact.

Figure 14 - Closer view of the cockpit

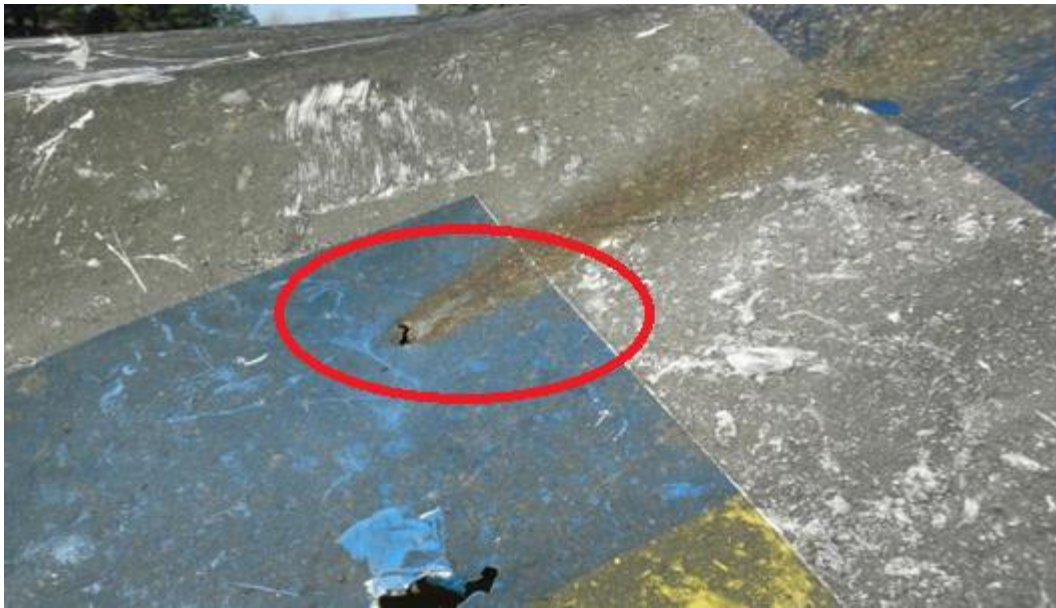
Laboratory results from the sample smoke layers around the holes show that the chemical base of the smoke was carbon, in which no traces of explosives were found.

Figure 16- Hole in the fuselage with a trace of a different color of smoke

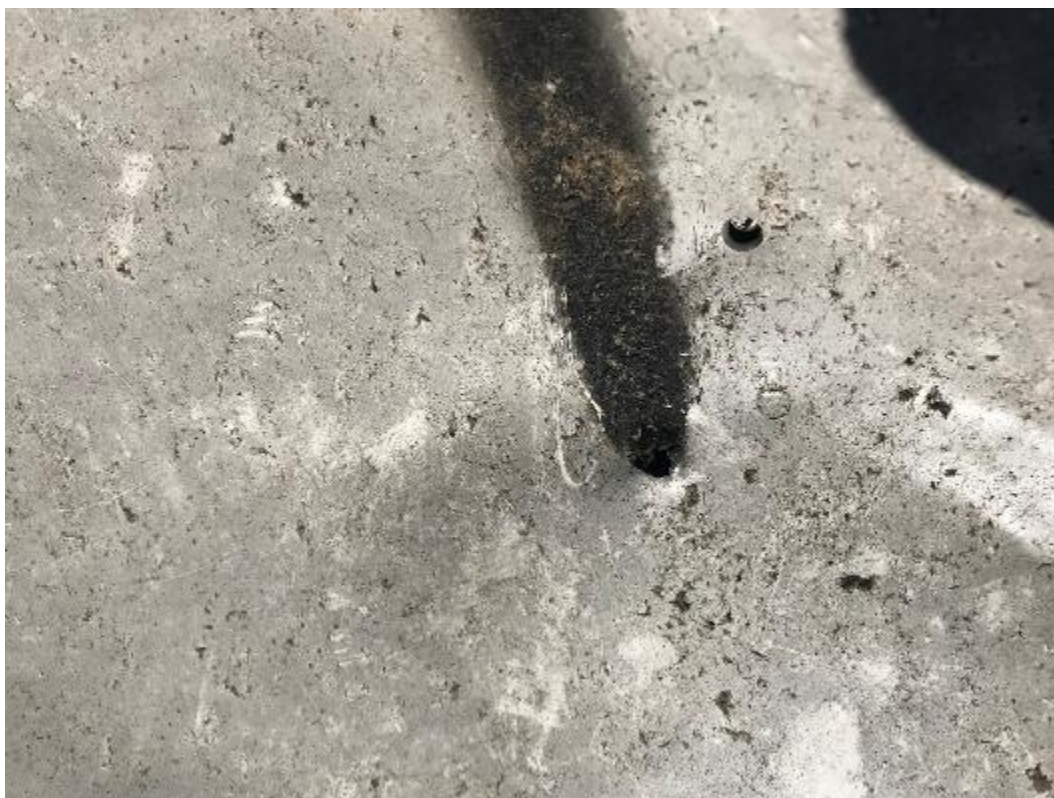
Figure 18- Hole on the fuselage near the cockpit and exhaust fumes

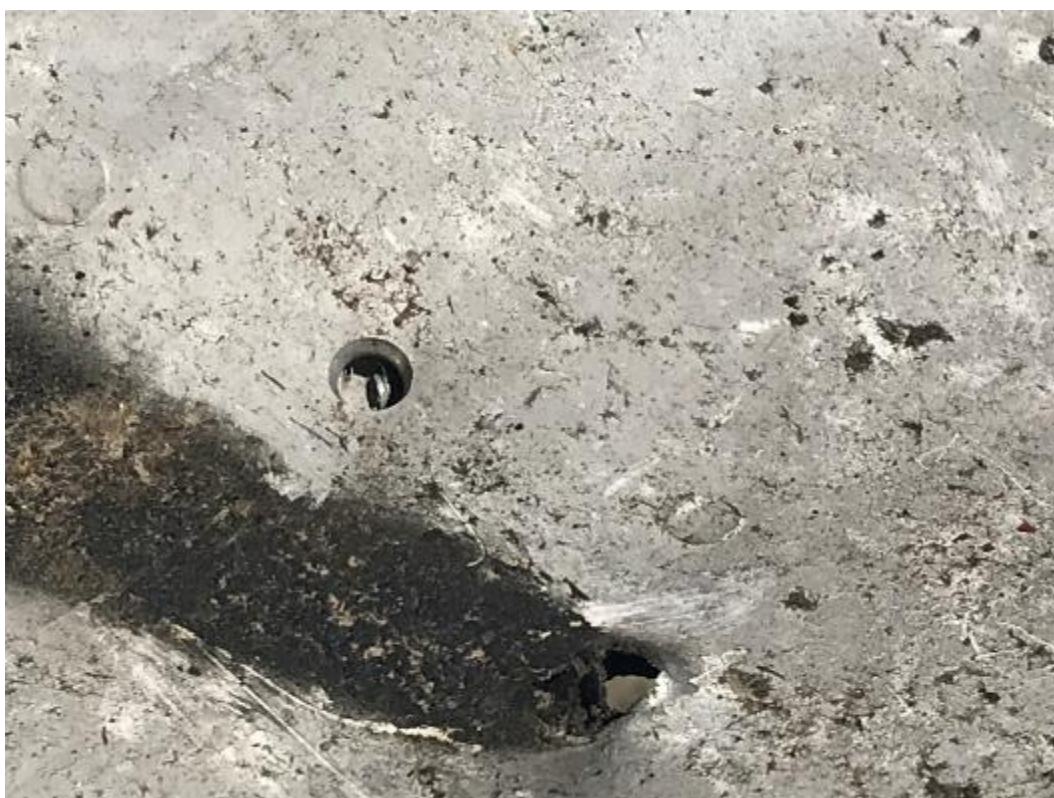
Figure 19- Closer view of the hole on the fuselage near the cockpit and burn signs in the hole area

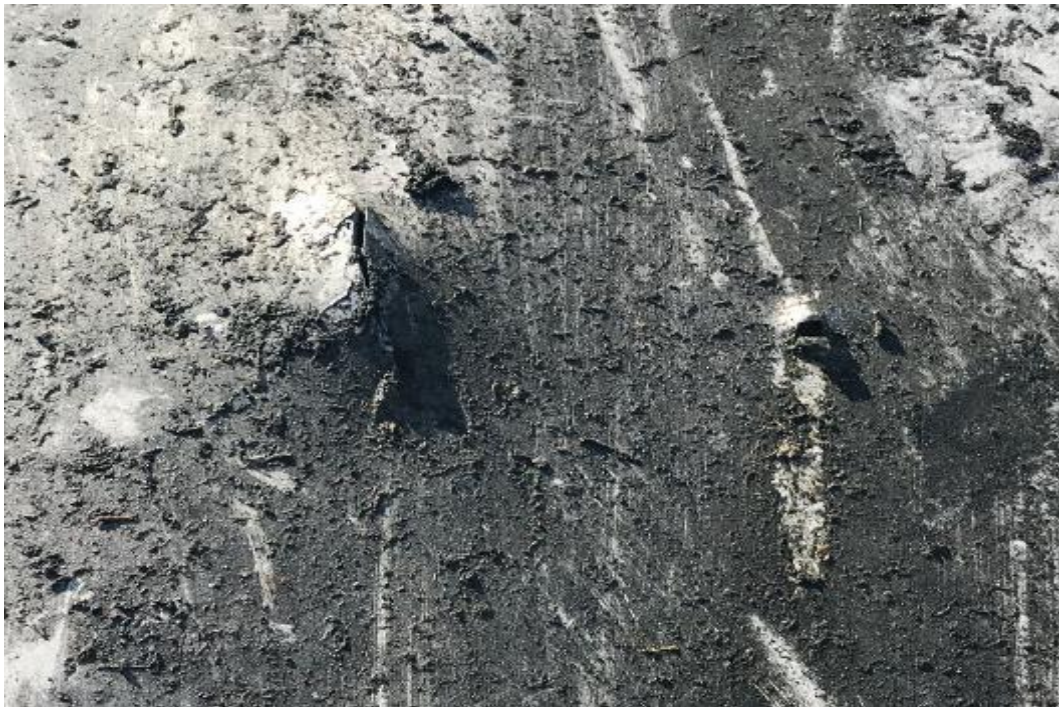
Figure 20- Crack with an outward hole in the skin of the structure near the cockpit

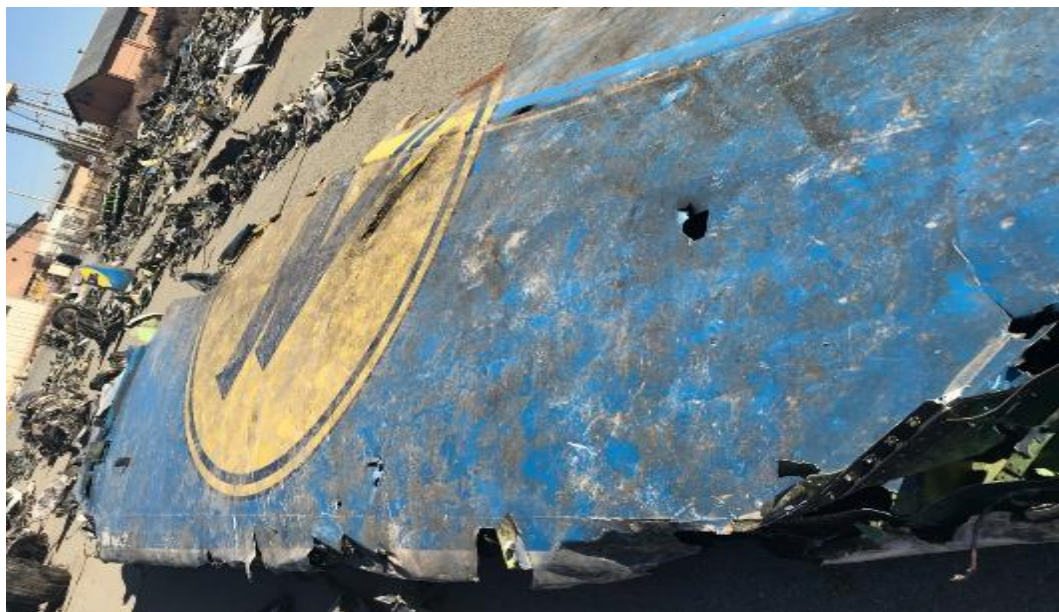
Figure 21- Holes and cracks on vertical stabilizer

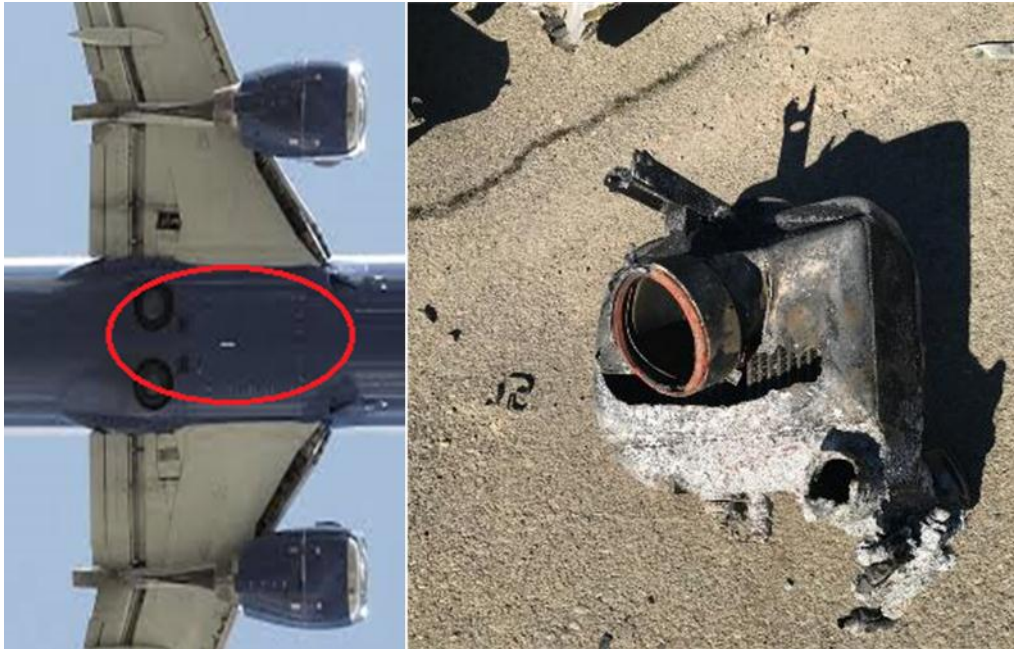
another heat exchanger found at the crash site, on which molten aluminum was observed, indicating a severe fire in this part.

Figure 22- The second heat exchanger found at the accident site and its installation point on the fuselage

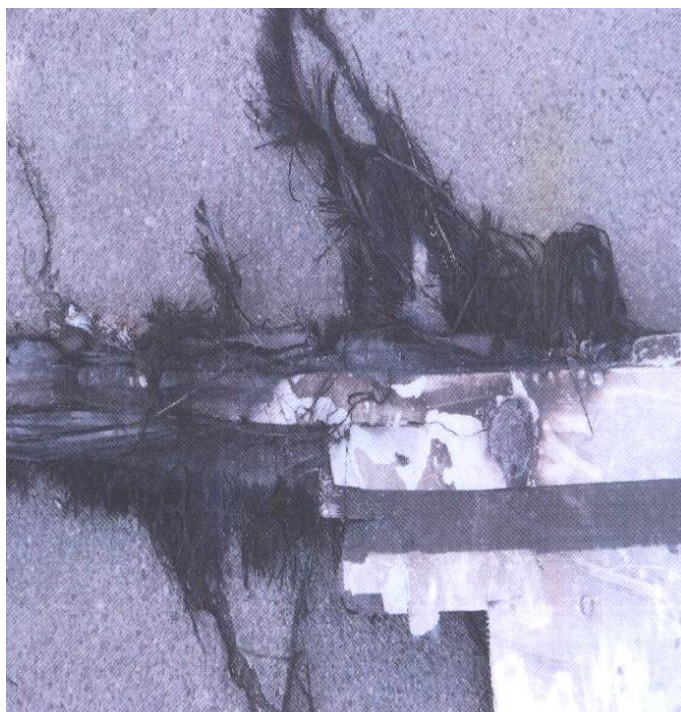
Based on the results yielded through GC/Mass chemical analysis, the existence of Trinitrotoluene (TNT) explosives with a chemical formula C₇H₅N₃O₆ was confirmed in the aircraft wing skin, which was found before the crash site. (Figure 27)

Figure 27- The wing piece found before the accident site

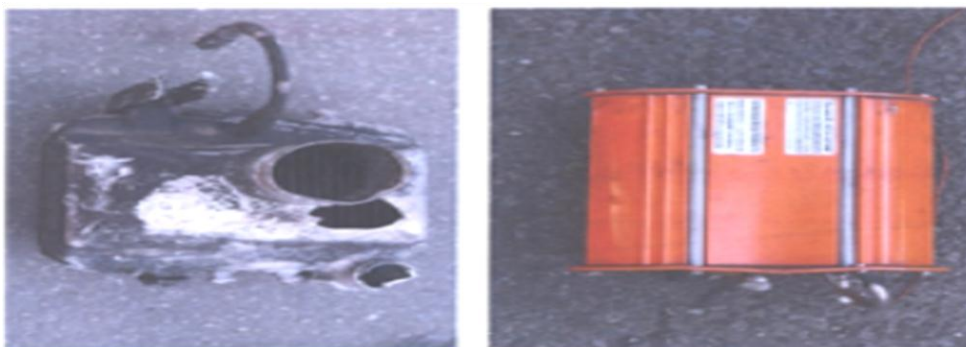
By sampling the air conditioning system and the two ELT pieces of the aircraft (Figure 29) and performing gas-chromatographic-mass spectrometry on each of the parts, the presence of negligible amounts of Dinitrotoluene (DNT) with the chemical formula $C_7H_6N_2O_4$ was proven.

Figure 29- Pieces on which the explosive test was done

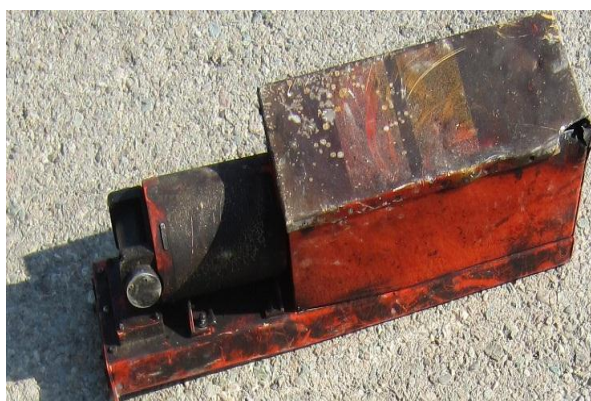
Figure 35- FDR physical appearance after the crash
