دفتر بررسی سوانح و حوادث هوایی

بررسی سانحه پرواز PS752

گزارش نهایی

شماره پرونده:	A981018URPSR
نوع رویداد:	سانحه
تاریخ رخداد:	۱۳۹۸/۱۰/۱۸
محل رخداد:	جمهوری اسلامی ایران- نزدیک فرودگاه بین‌المللی امام خمینی (ره) (OIIE)
نوع هواپیما:	بوئینگ ۷۳۷ سری ۸۰۰
علامت ثبت:	UR-PSR
تاریخ صدور:	۱۳۹۹/۱۲/۲۵

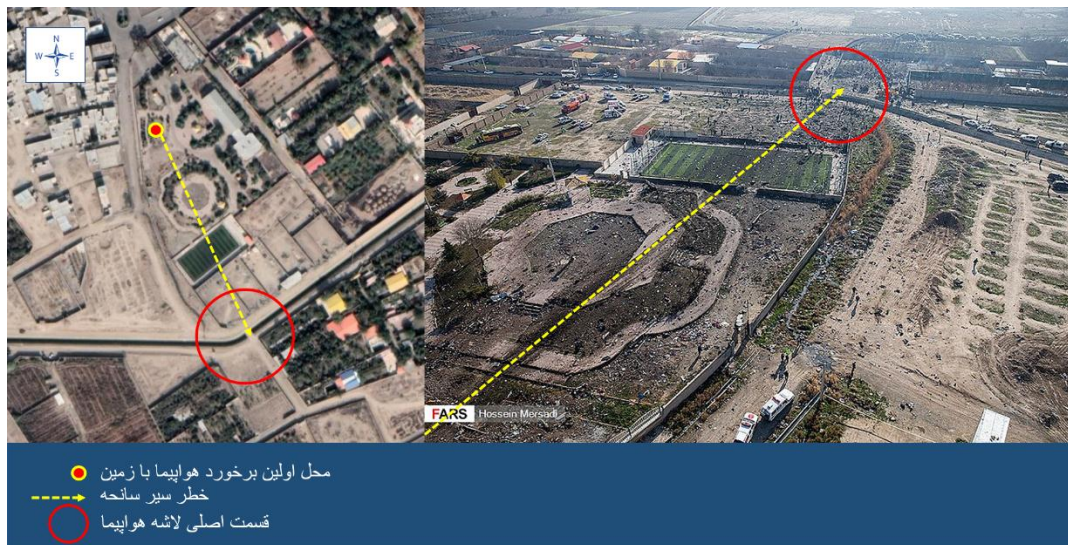
هواپیما پس از کاهش ارتفاع از منطقه مسکونی «خلج آباد» رد شده و اولین برخورد آن با سقف یک آلاچیق در یک پارک تفریحی به نام «لاله» بوده است. سپس بدنه هواپیما با زمین برخورد کرده و پس از عبور از یک زمین بازی فوتبال، به طور کامل از هم گسیخته و در مزارع و باغات کشاورزی اطراف پخش شده و به آنها صدمه زده است. پس از برخورد اولیه، در طول خط سیر آن برخوردهای دیگری با عوارض زمینی مشاهده شده و بدنه هواپیما متلاشی گردیده و در طول خط سیر پخش شده است (شکل ۳. Error! Reference source not found.).

شکل ۳- نمای کلی سایت سانحه

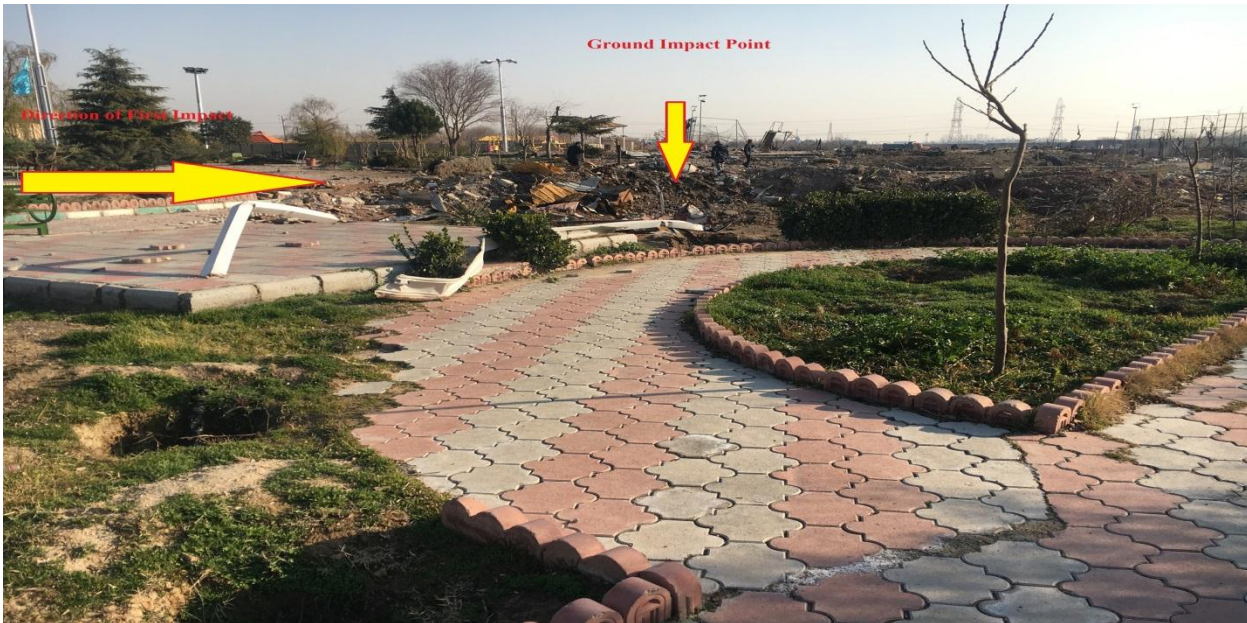
برخورد هواپیما با زمین باعث ایجاد یک حفره در زمین پارک شده و سپس بدنه هواپیما، از زمین فاصله گرفته و به سمت یک زمین فوتبال ادامه مسیر داده و با برخورد با فنس‌های محافظتی آن مسیر را ادامه داده و با عبور از یک کانال آب به دیوارهای محافظتی باغهای شخصی برخورد و متلاشی و قطعات آن به تریبی که در شکل ۸ مشخص است پراکنده شده‌اند. شواهد و قطعات جمع‌آوری شده از هواپیما در سایت اصلی سانحه نشان می‌دهد که هواپیما قبل از برخورد به زمین هنوز از انسجام نسبی برخوردار بوده و مصاحبه با شاهدان عینی در مسیر پرواز نیز موید این موضوع است.

شکل ۷- محل اولین برخورد هواپیما با زمین

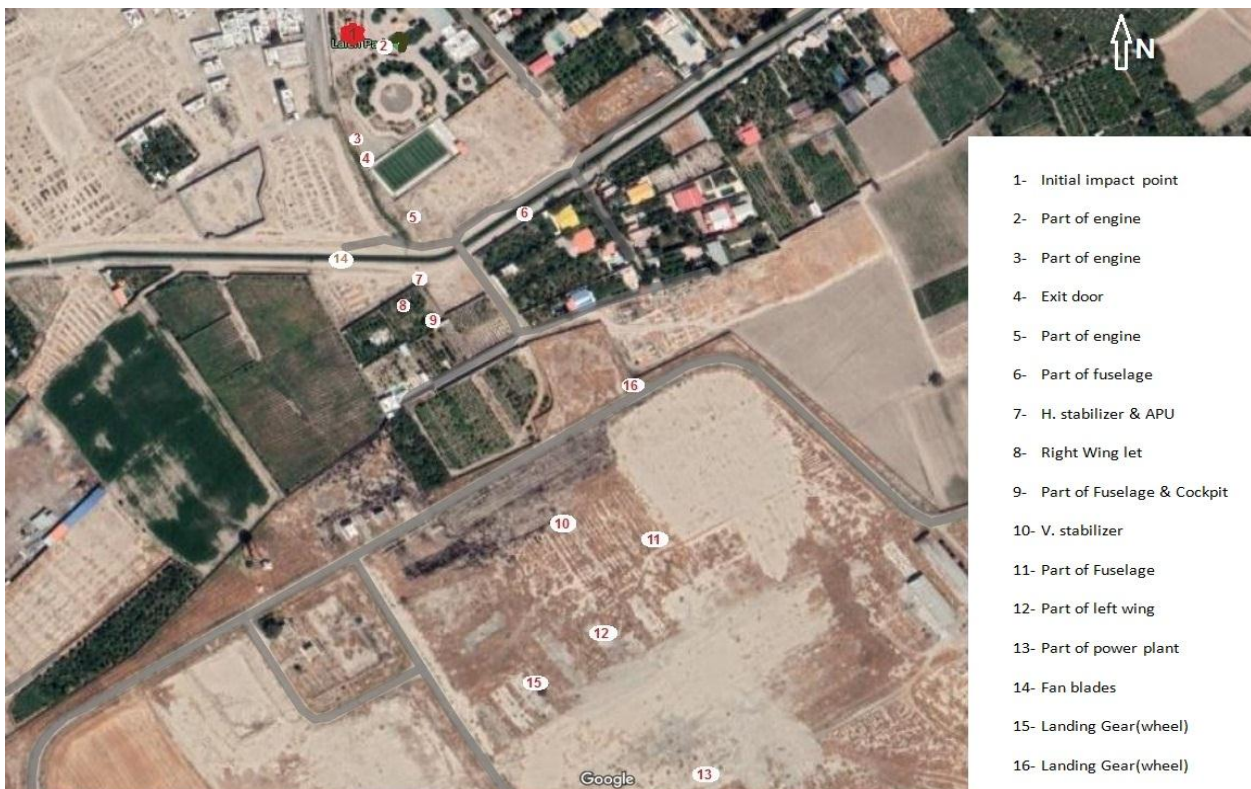
شکل ۸- جانمایی کلی پراکنش قطعات هواپیما

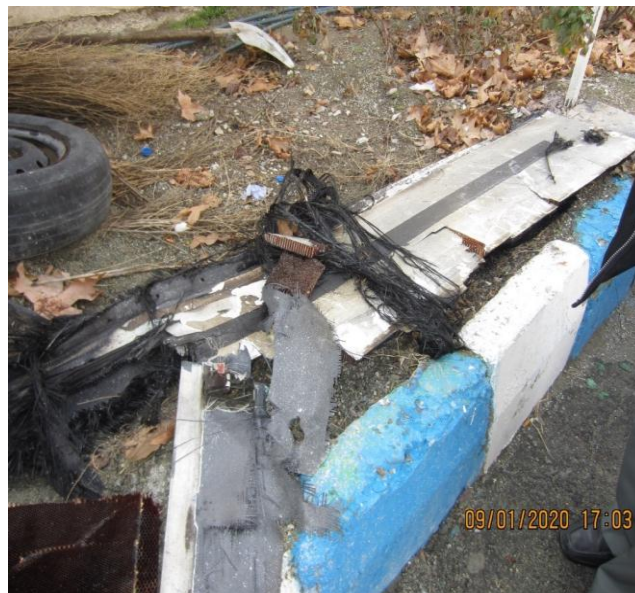
در خلال عبور پرواز از روستای «بکه» از توابع شهریار، قطعاتی از پانل‌های متعلق به سطوح پوششی انتهای عقب بال هواپیما جدا شده (شکل ۹) و در مشخصات جغرافیایی $35^{\circ}35'55''N50^{\circ}59'43''E$ بر روی زمین افتاده و برخی قطعات ریز و یک قطعه از سیستم تهویه (شکل ۱۰) در موقعیت $35^{\circ}35'53''N50^{\circ}59'43''E$ حدود ۱۰ کیلومتر قبل از سایت سانحه از هواپیما بر روی زمین افتاده بود و توسط اهالی مناطق مسکونی جمع آوری و تحویل مقامات محلی شده است.

شکل ۹- قسمتی از بال هواپیما که قبل از محل برخورد بر روی زمین افتاده بود

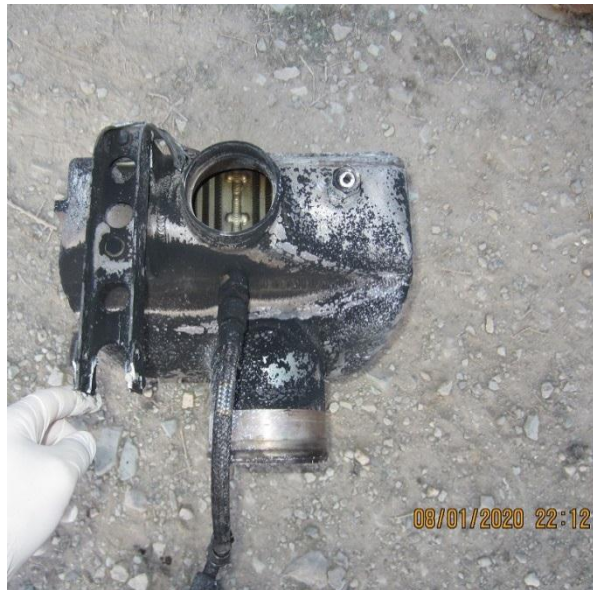
شکل ۱۰- بخشی از سامانه تهویه که قبل از محل برخورد بر روی زمین افتاده بود

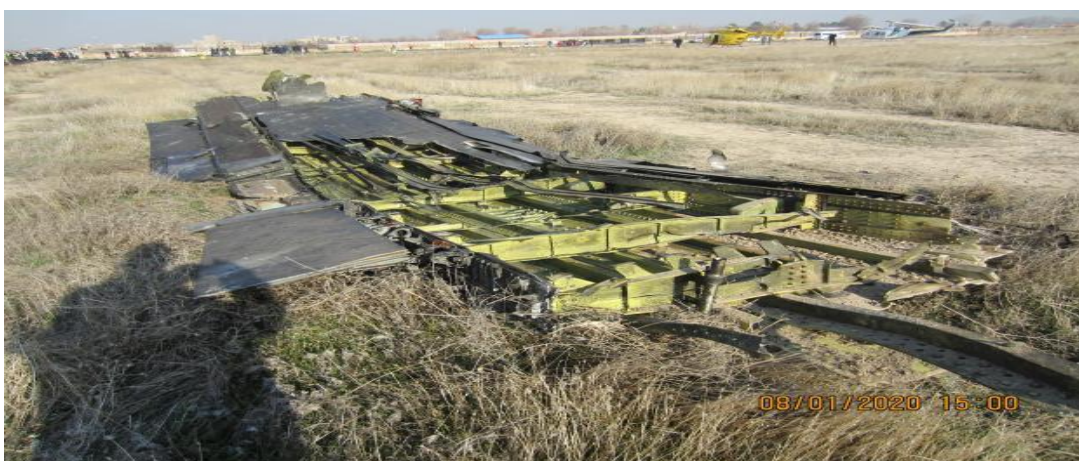
پوسته بیرونی بال سمت چپ هواپیما دارای آثار سوختگی است، عدم وجود آثار حریق در محل پیدا شدن قطعه و سالم بودن پوشش گیاهی اطراف آن حاکی از این است که سوختگی بال قبل از برخورد هواپیما به زمین بوده است. دیواره‌های داخلی بال نشان از عدم سرایت آتش به داخل مخزن سوخت هواپیما دارد. (شکل ۱۱)

شکل ۱۱- بال چپ هواپیما در محل سانحه

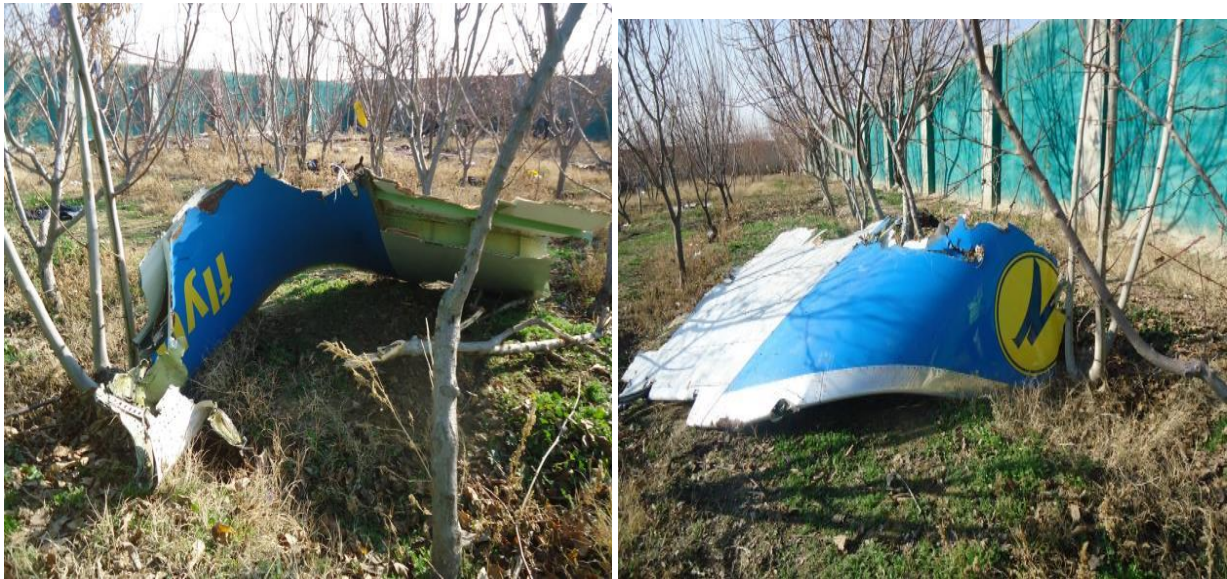
ظاهر قسمت هایی از بال سمت راست هواپیما به همراه بالک^{۲۳} آن، نشان از عدم سرایت آتش سوزی به سمت راست هواپیما است (شکل ۱۲).

شکل ۱۲- بالک راست هواپیما

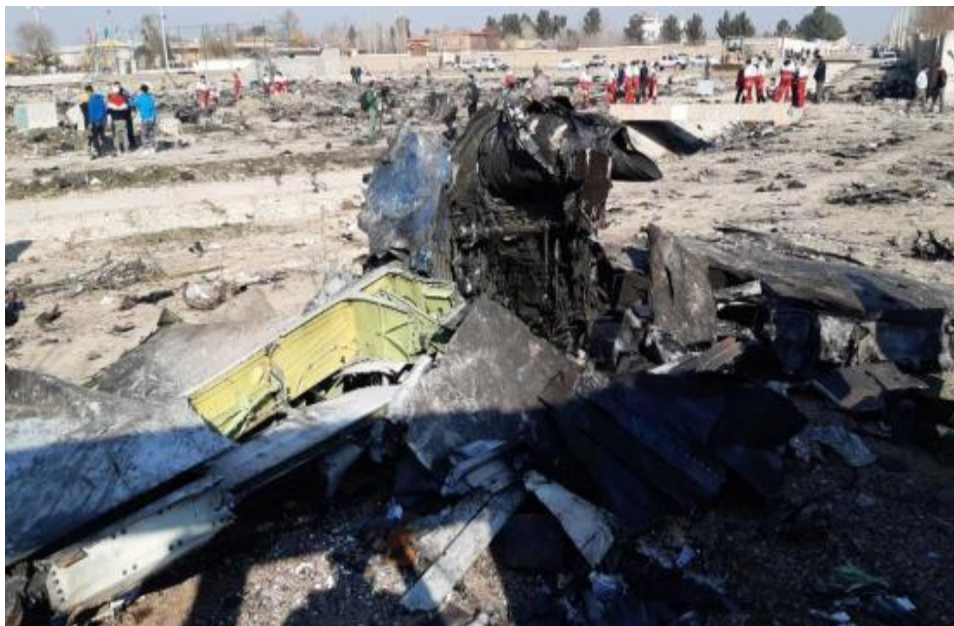
در کنار محفظه موتور مولد کمکی^{۲۴} آثار دود و سوختگی بر روی زمین مشاهده شده است (شکل ۱۳).

شکل ۱۳- موتور مولد کمکی

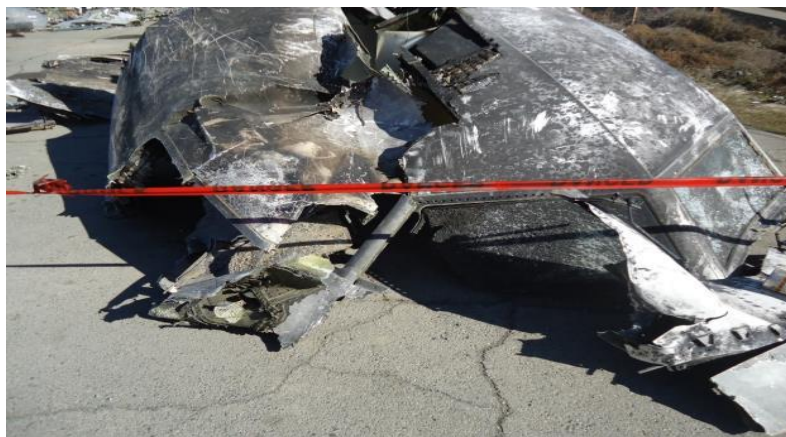
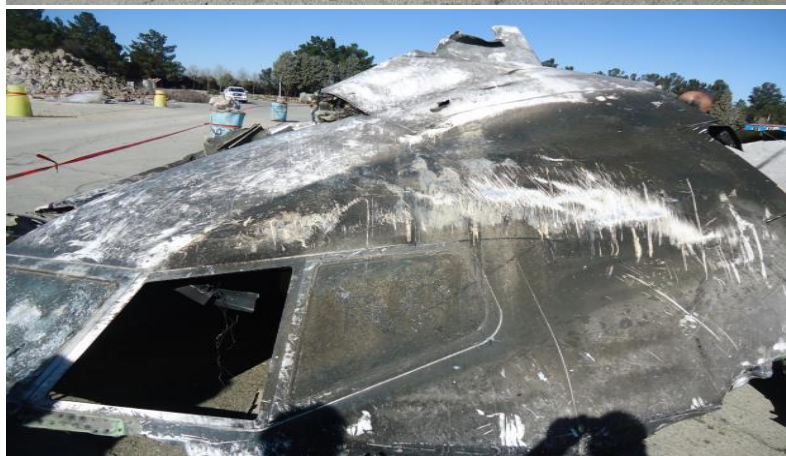
در روی کابین خلبان اثر آتش سوزی شدید مشاهده می‌شود (شکل ۱۴).

آثار آتش سوزی و دود روی پوسته خارجی کابین خلبان به دو حالت قبل و پس از برخورد به زمین بوده که نشان می‌دهد که بدنه هواپیما قبل از برخورد به موانع زمینی دارای آتش سوزی بوده است.

شکل ۱۴- نمای نزدیک تری از کابین خلبان

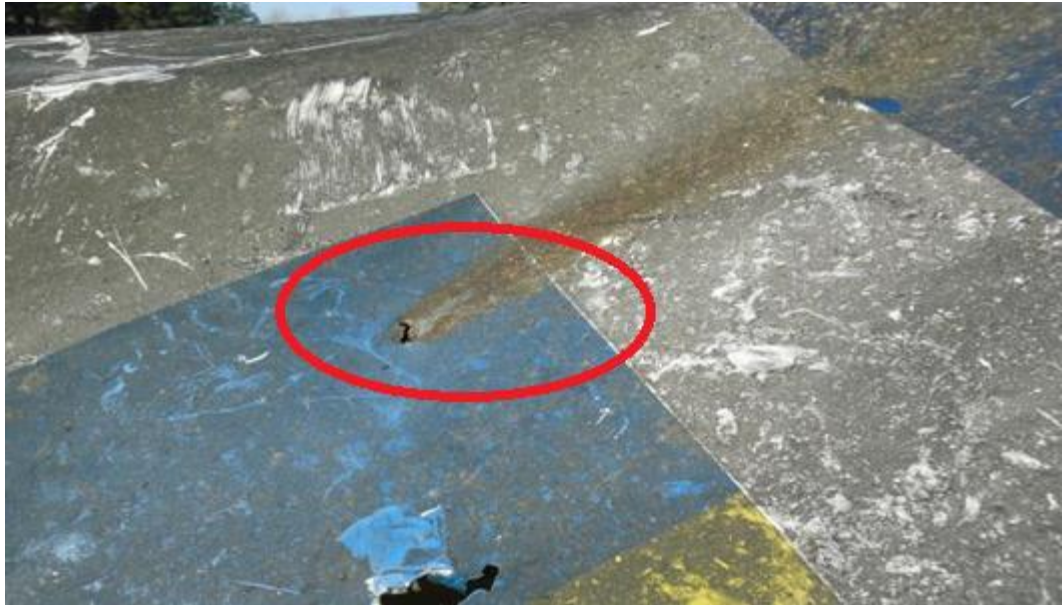
تعداد زیادی سوراخ و پارگی در روی بدنه هواپیما دیده می‌شود که از نظر اندازه و شکل و همچنین جهت باز شدن متنوع هستند، لیکن دو دسته مجزا قابل رویت است. در یک دسته از سوراخ‌ها که تعداد کمتری هستند، آثار جریان دود غلیظ به سمت بیرون بدنه دیده می‌شود (شکل ۱۶، شکل ۱۷، شکل ۱۸ و شکل ۱۹) و در دسته دیگر که تعداد بیشتری هستند (شکل ۲۰ و شکل ۲۱)، تنها سوراخ و پارگی مشاهده می‌شود.

در سقف کابین در امتداد محفظه الکترونیکی تعداد محدود و اندکی سوراخ و اثرات برخورد شیء کوچک از داخل به خارج مشاهده میشود. خط سیر دود غلیظ خارج شده از آنها نشان می‌دهد که این سوراخ‌ها قبل از برخورد با زمین وجود داشته و در زمانی که هواپیما در حال پرواز بوده، دود از حفره‌ها خارج می‌شده است.

نتایج آزمایشگاهی از نمونه لایه های دود در اطراف سوراخ‌ها نشان می‌دهد که پایه شیمیایی دودها کربنی بوده و آثاری از موارد منفجره در داخل کابین یافت نشده است.

شکل ۱۶- سوراخ بدنه هواپیما با ردی از رنگی متمایز از دود

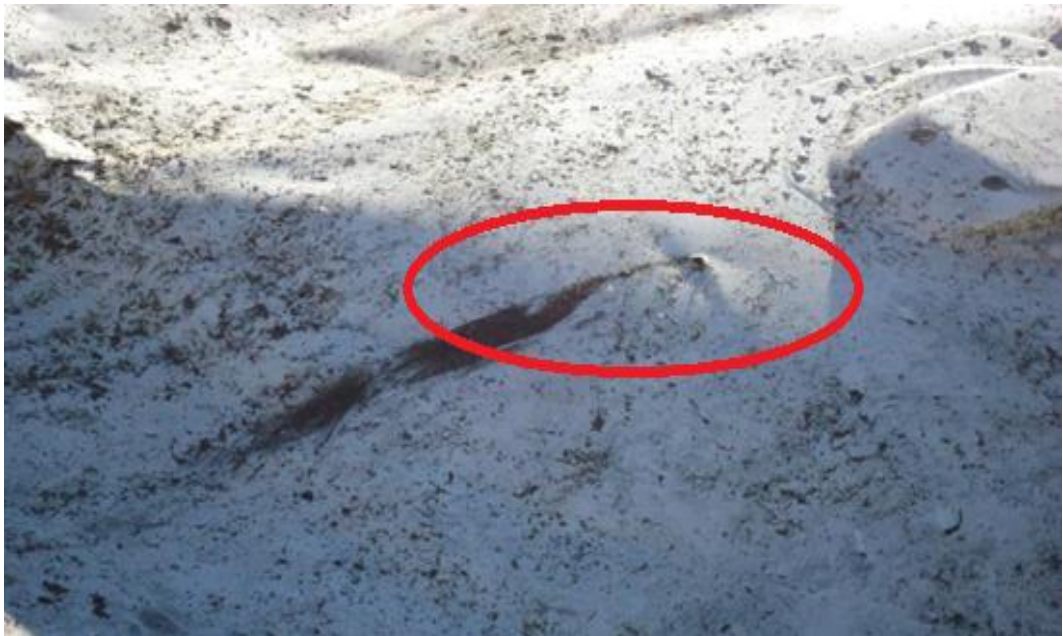
شکل ۱۷- سوراخ روی بدنه هواپیما نزدیک کابین با ردی از رنگی متمایز از دود

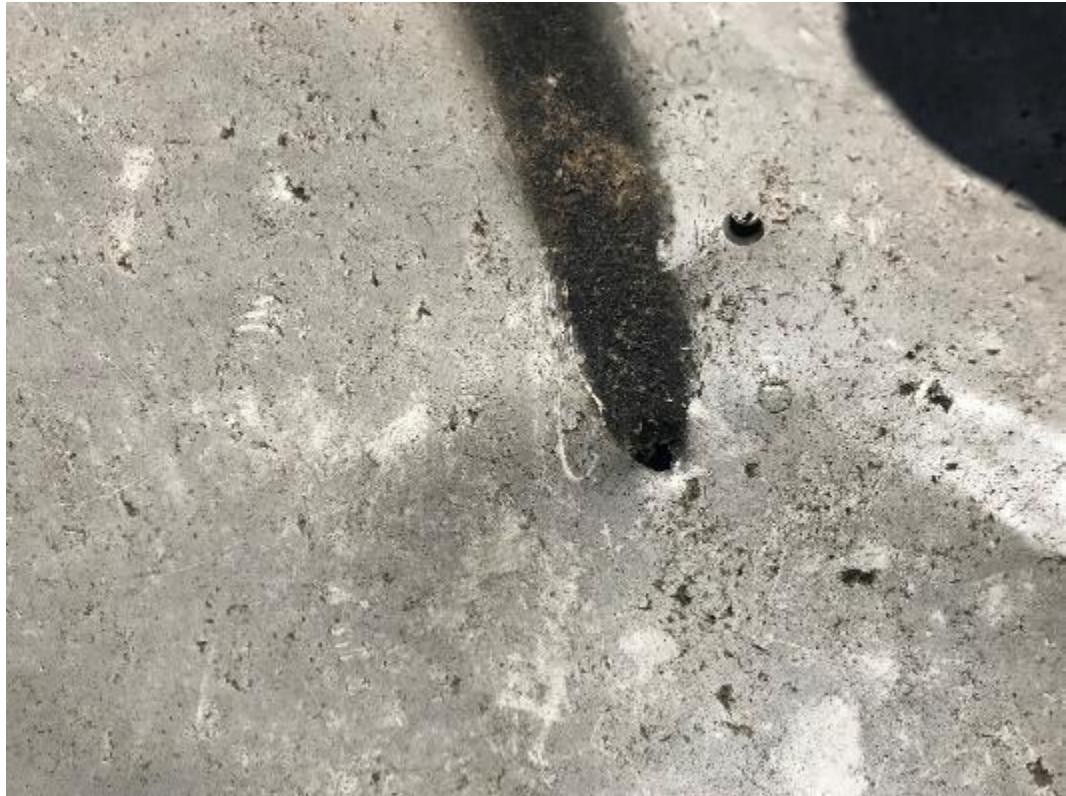
شکل ۱۸- سوراخ روی بدنه نزدیک کابین خلبان هواپیما و دود خروجی

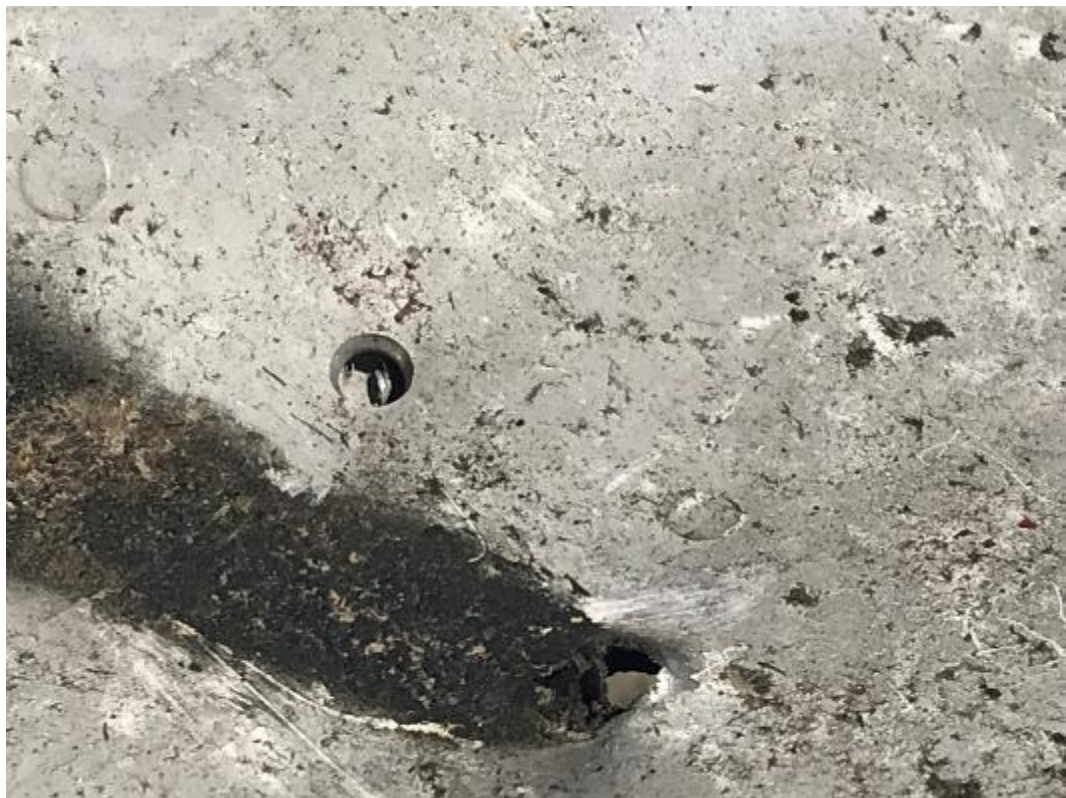
شکل ۱۹- نمای نزدیکتر از سوراخ روی بدنه نزدیک کابین خلبان و آثار سوختگی در ناحیه سوراخ

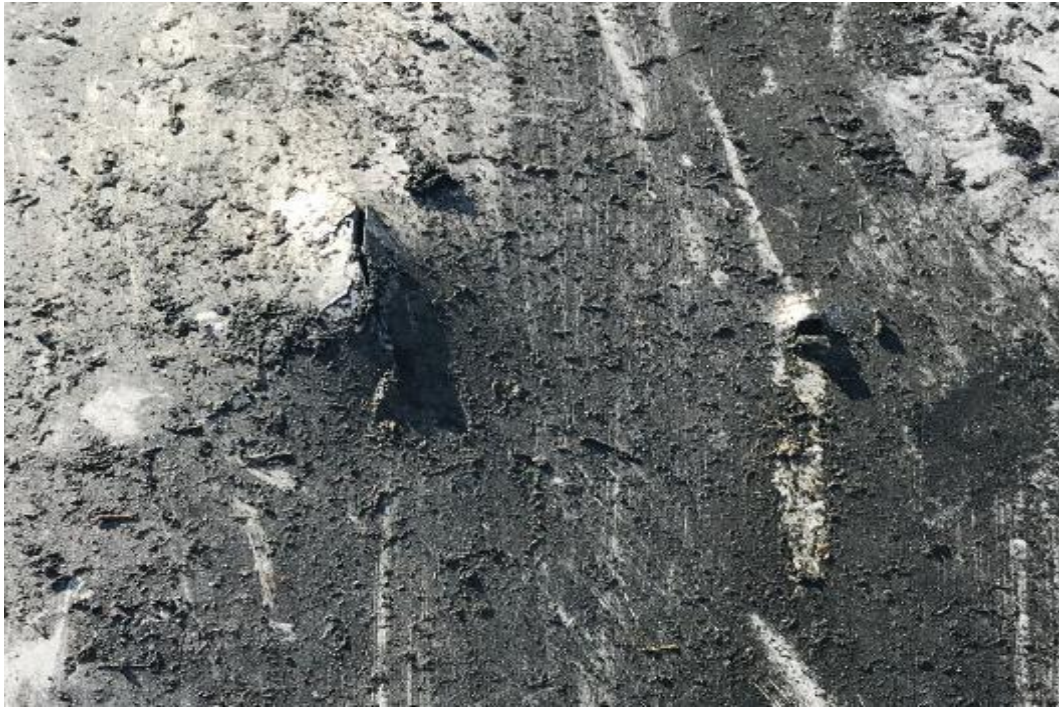
شکل ۲۰- شکستگی به همراه سوراخ رو به بیرون در پوسته سازه نزدیک به کابین هواپیما

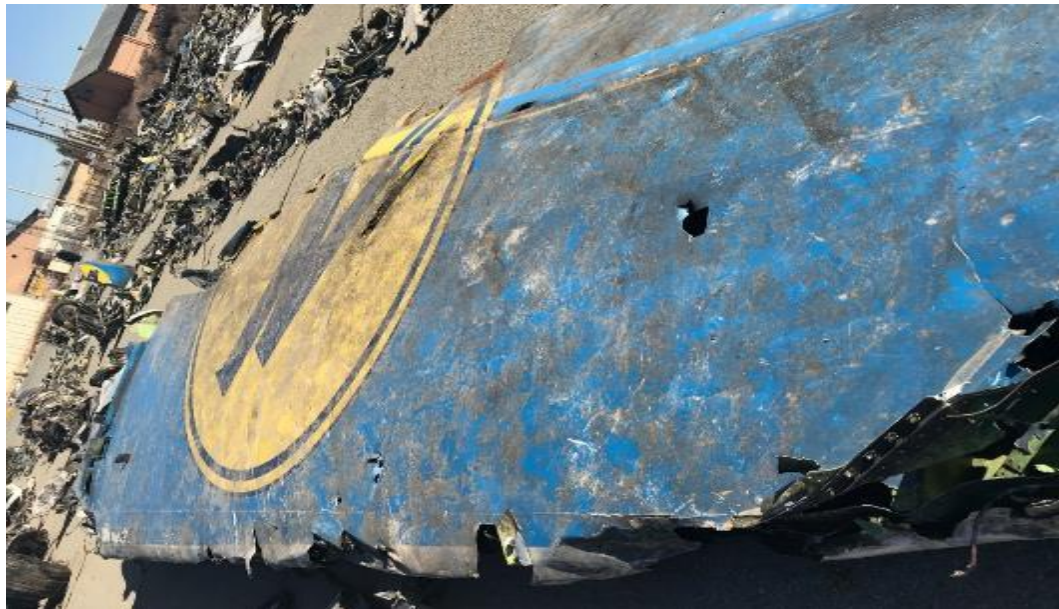
شکل ۲۱- سوراخ و پارگی‌های روی سکان عمودی هواپیما

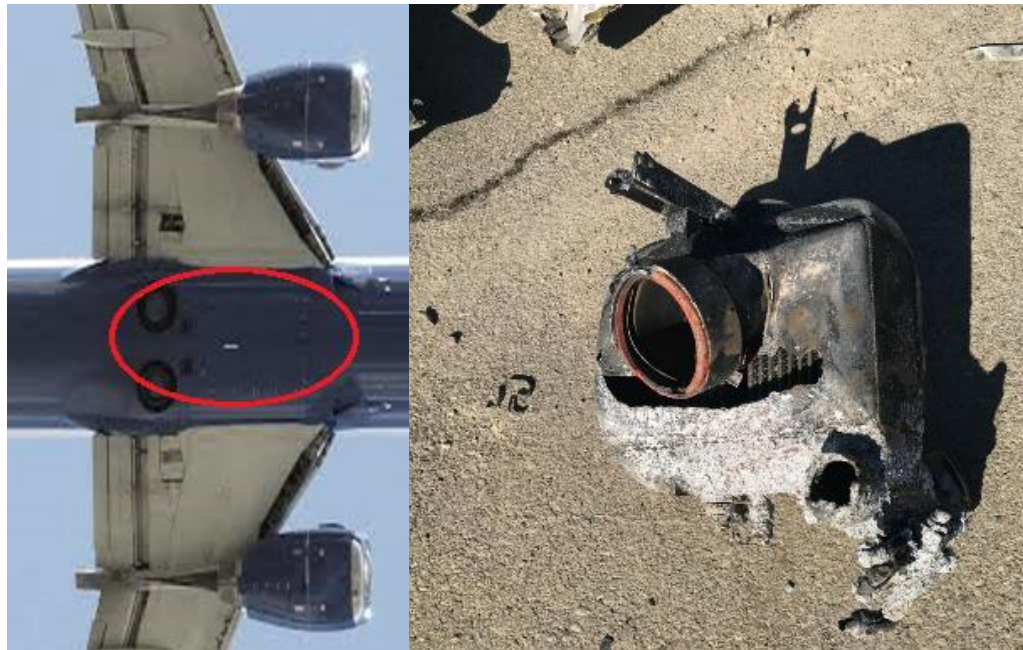
در بخش مرکزی هواپیما زیر و سمت چپ بین بدنه و بال آثار سوختگی در مجاورت بخش سیستم تهویه هوای کابین مشاهده میشود که این قسمت محل نصب پیش خنک کننده تهویه یافته قبل از محل سایت در روستای حوالی جندق می باشد. یک مبدل حرارتی دیگر نیز در همان قسمت هواپیما وجود داشته که در سایت سانحه پیدا شده است بر روی این قطعه آلومینیوم ذوب شده مشاهده شده که نشان از آتش سوزی شدید در این قسمت می باشد.

شکل ۲۲- دومین مبدل حرارتی یافته شده در محل سانحه و محل نصب آن بر روی هواپیما

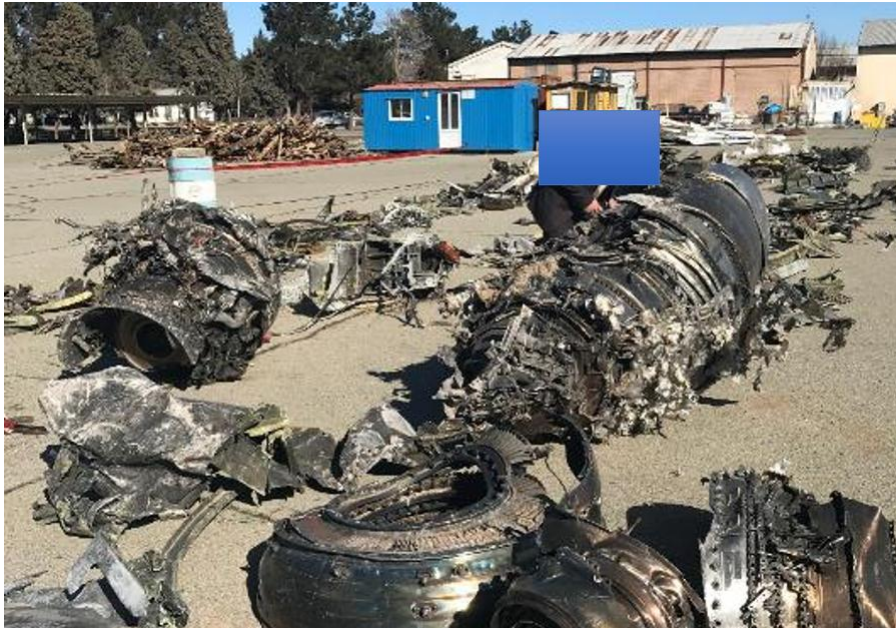
دو موتور هواپیما در سایت مشاهده شده و بطور کلی صدمه دیده اند (شکل ۲۳). از صدمات مشهود روی قطعات گردنده به نظر می رسد که این قطعات در حال گردش دچار سانحه شده اند. بررسی موتورهای هواپیما، آثار قابل توجهی از آتش سوزی و یا انفجار را نشان نمی دهد و به نظر می رسد که عمده آسیب وارده ناشی از تغییر شکل در اثر برخورد با زمین می باشد.

شکل ۲۳- دو موتور هواپیما

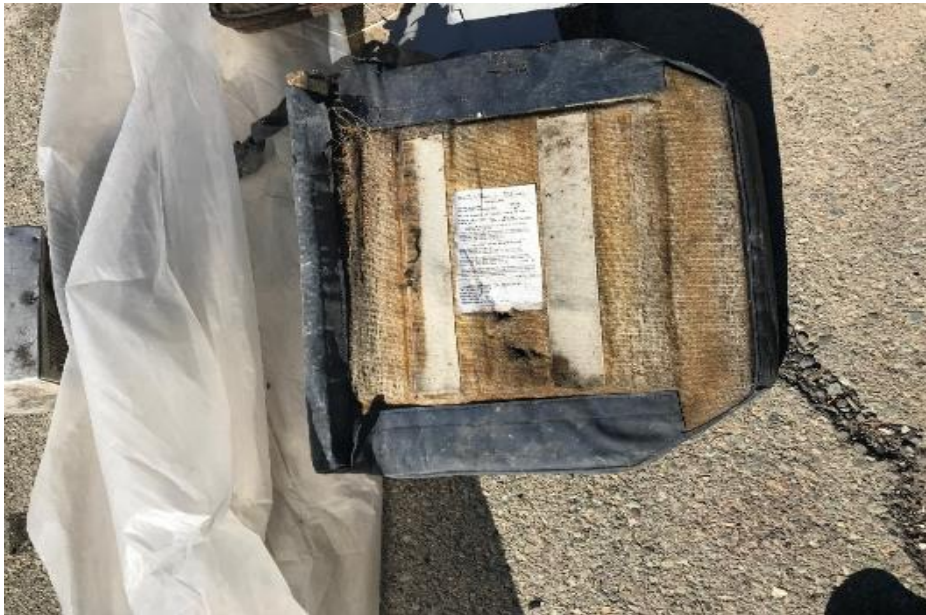
شکل ۲۵- یکی از کفی‌های صندلی مسافر باقیمانده هواپیما با جای سوراخ

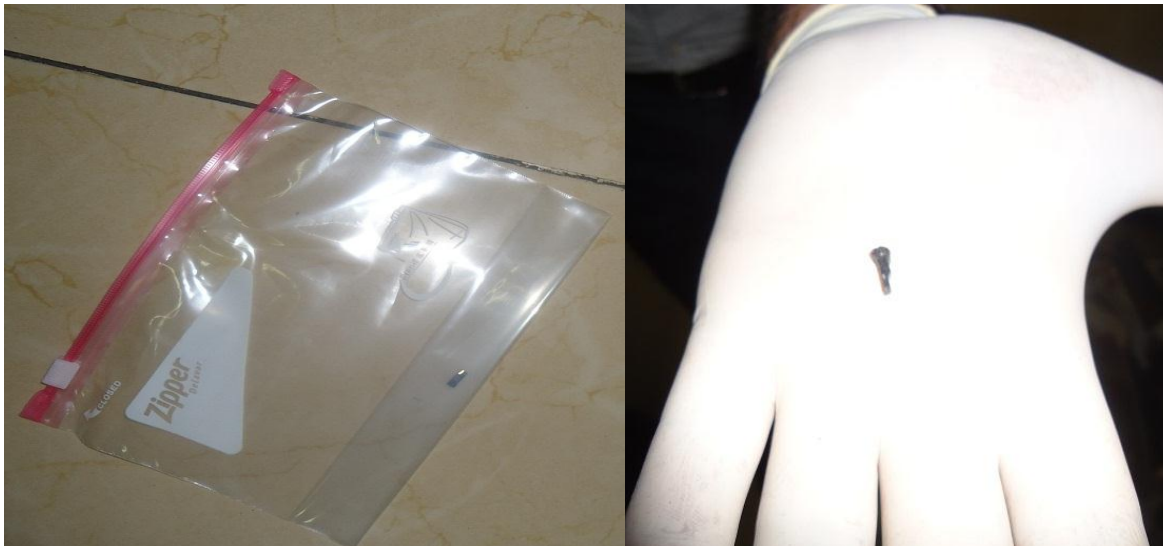
شکل ۲۶- کشف موارد فلزی در صندلی مسافرین

نتایج حاصل از طیف سنجی فلورسنس پرتو ایکس^{۳۰} نشان دهنده وجود دو نوع متفاوت فلز در قطعات پیدا شده در تشکک صندلی مسافران است. این نتایج که در جدول ۴ آورده شده، نشان می‌دهد که این قطعات مربوط به آلیاژهای هواپیما بوده است و متناسب با فلز تنگستن (جنس ترکش موشک) نیست.

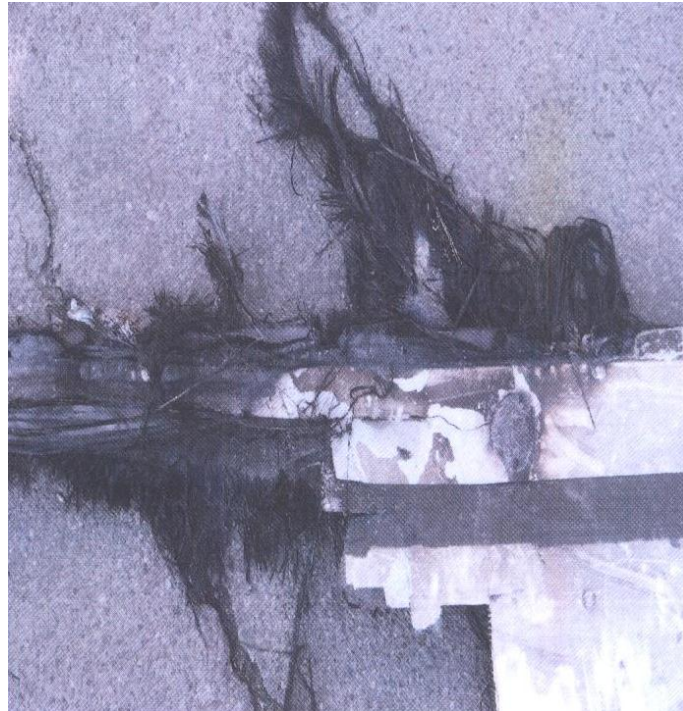
طبق نتایج به دست آمده از آنالیز شیمیایی GC/Mass، وجود آلودگی به ماده منفجره تری نیترو تولوئن (TNT) با فرمول شیمیایی $C_7H_5N_3O_6$ در پوسته زیر بال هواپیما موجود در سازمان هواپیمایی کشوری که قبل از محل سقوط یافت شده بود (شکل ۲۷)، شناسایی شد.

شکل ۲۷- قطعه‌ای از بال یافت شده قبل از محل سانحه

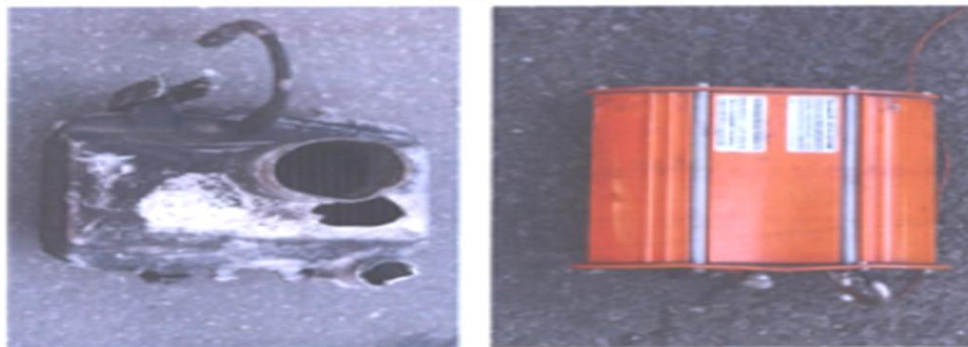
با نمونه‌گیری از قطعه سیستم تهویه هوا و دو قطعه فرستنده اضطراری هواپیما (شکل ۲۹) و انجام آنالیز کروماتوگرافی گازی- طیف سنجی جرمی روی هر کدام از قطعات وجود ماده دی نیتروتولون (DNT) با فرمول شیمیایی $C_7H_6N_2O_4$ به مقدار ناچیز محرز گردید.

شکل ۲۹- قطعات مورد آزمایش مواد منفجره

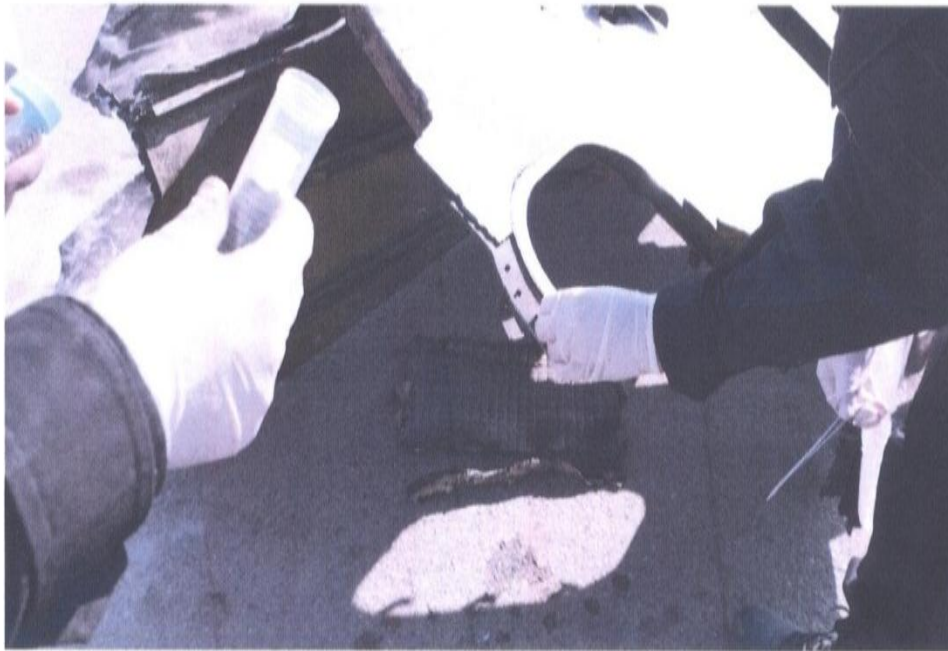
طبق بررسی طیف به دست آمده از قسمت داخلی بخشی از پنجره کابین هواپیما نیز (طبق شکل ۳۱)، وجود ماده انفجاری تری نیترو تولوئن (TNT) مشخص گردید (شکل ۳۲).

شکل ۳۱- قسمتی داخلی از پنجره هواپیما

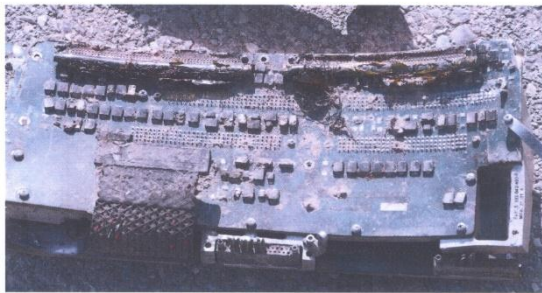
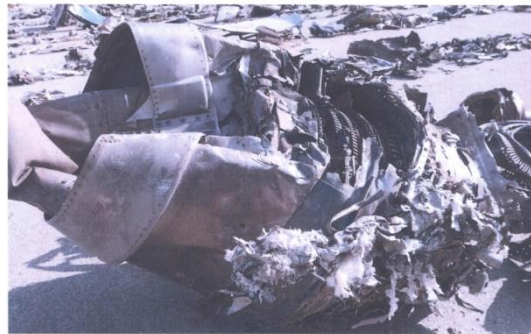
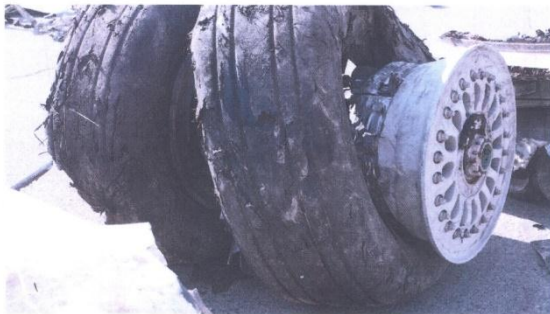
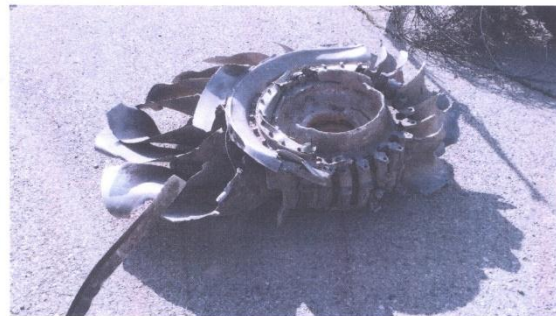
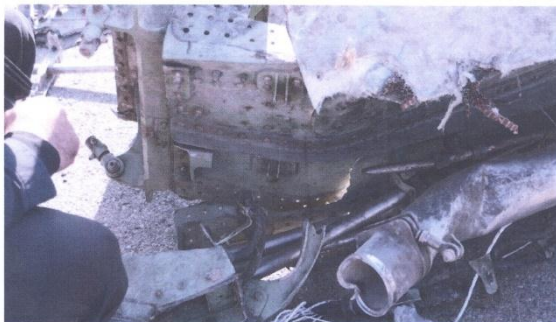
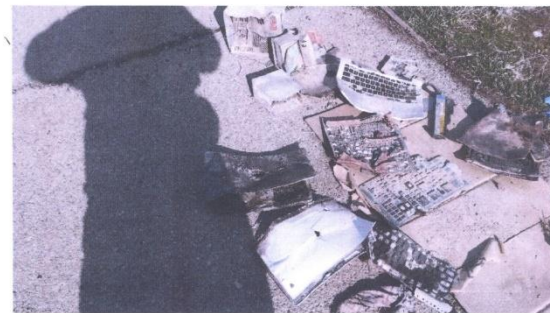
شایان ذکر است در نمونه های گرفته شده از موتورها، قطعات دیگر هواپیما یا اشیاء داخل کابین مسافران که تصاویر برخی از آنها در شکل ۳۳ آمده است هیچ نوع آلودگی به مواد انفجاری مشاهده نگردید.

شکل ۳۳- قطعات و بخش هایی از هواپیما که نشانه ای از آلودگی به مواد منفجره نداشتند.

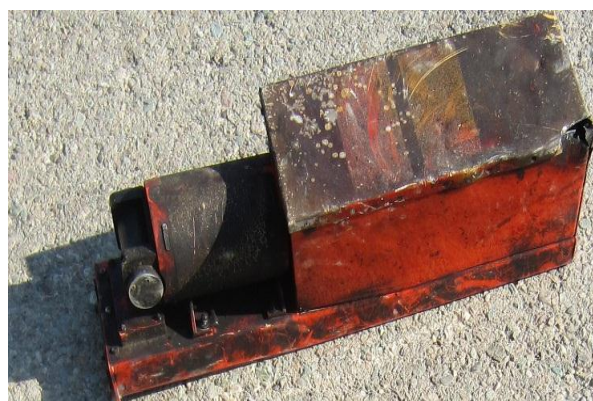
هر دو دستگاه دارای صدمات ظاهری بودند. صدمه ظاهری به دستگاه ضبط صدای کابین بیشتر بوده و بر اثر ضربه حافظه اصلی آن جدا شده بود. وضعیت این دستگاه‌ها نشان می‌دهد که در معرض آتش سوزی در پرواز نبوده‌اند و بر اثر شدت برخورد به زمین دچار صدمات فیزیکی شده و یا در معرض آتش قرار گرفته‌اند. (شکل ۳۵ و شکل

شکل ۳۵- وضعیت ظاهری ضبط کننده داده‌های پروازی پس از سانحه

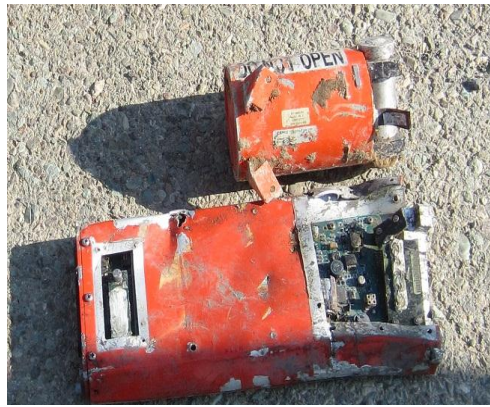
شکل ۳۶- وضعیت ظاهری ضبط کننده صدای کابین پس از سانحه

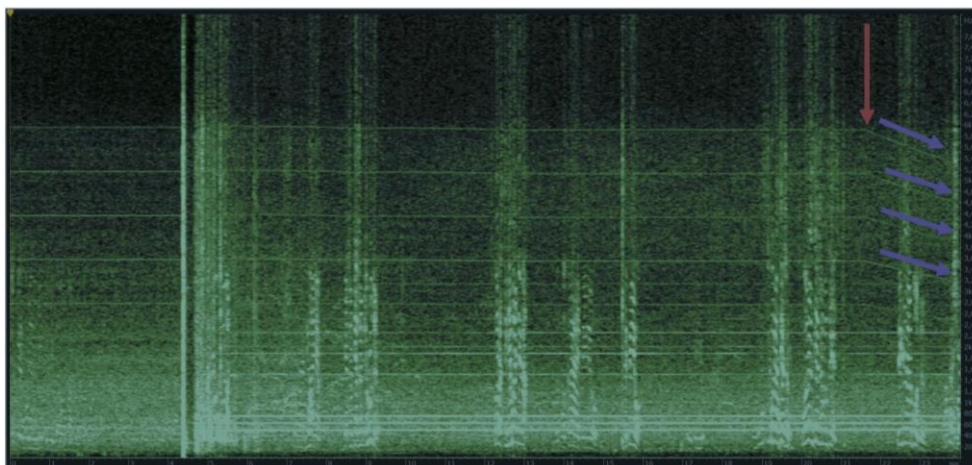
یک افت فرکانسی از زمان 2.445 ثانیه قبل از پایان ضبط آغاز می‌شود (شکل ۴۰).

شکل ۴۰- افت فرکانس‌های ضبط شده در ضبط کننده صداهای کابین - تصویر از BEA

پس از انفجار موشک اول در مجاورت هواپیما، به صورت همزمان، ترانسپاندر مراقبت پرواز و ضبط کننده داده‌های پروازی به دلیل صدمات وارد شده از کار می‌افتند. هواپیما دچار آسیبی رو به گسترش می‌شود که در نتیجه آن، پس از حدود ۱۶/۵ ثانیه، دور یکی از ژنراتورهای تامین کننده برق^{۶۱} ضبط کننده‌های صدای کابین شروع به کاهش می‌کند و باعث تغییر در فرکانس صداها می‌شود و در نهایت قطع ضبط صداها کابین می‌شود.

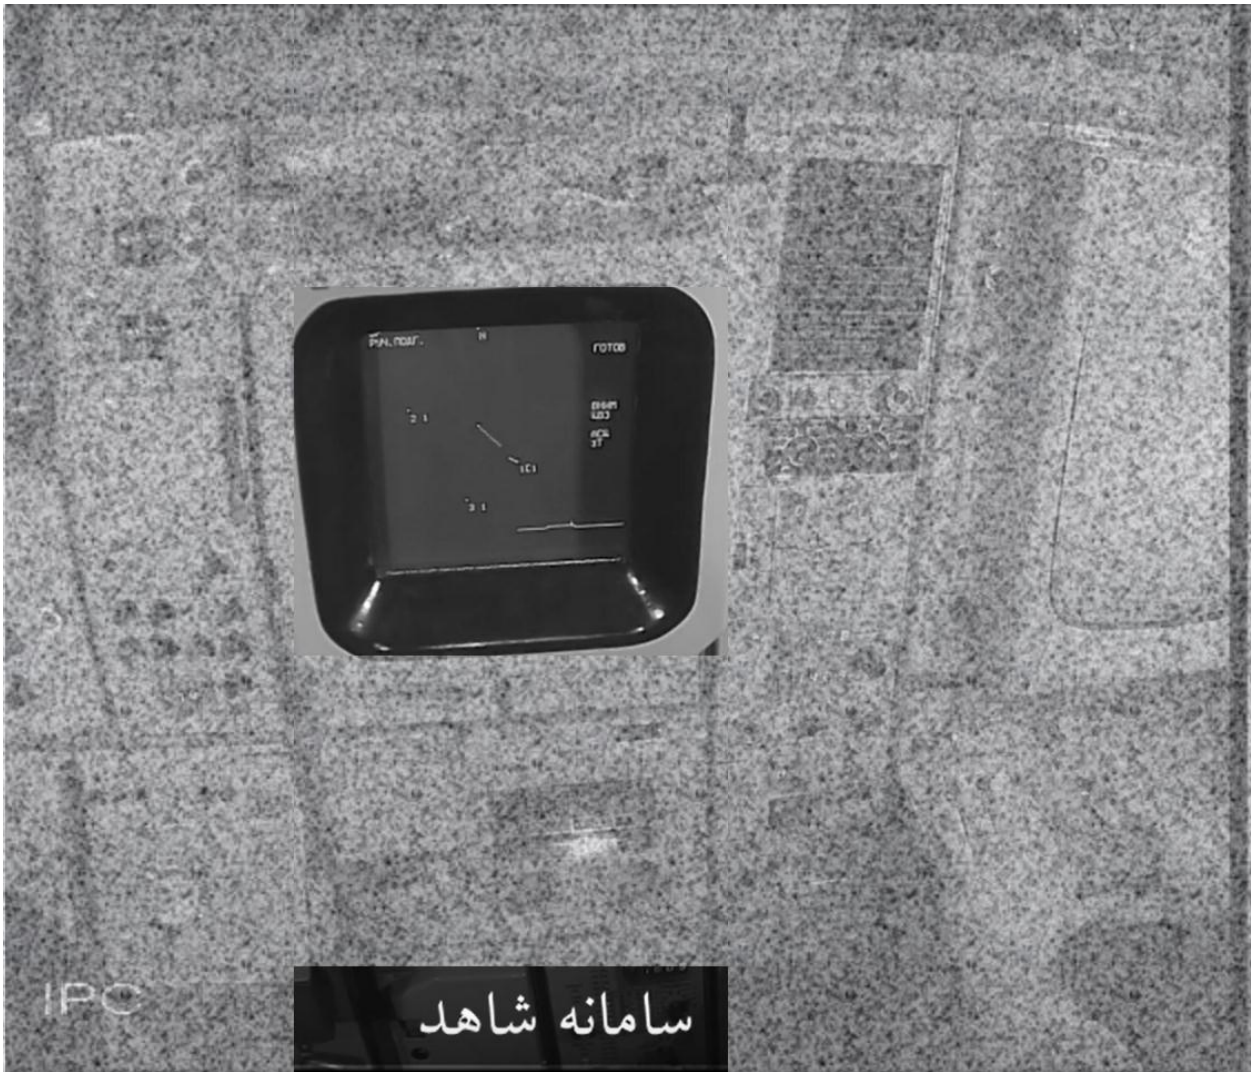
این شبیه‌سازی نیز نشان داد که عملیات پروازی هواپیما نقشی در ایجاد خطای سامانه نداشته و در هر دوبار شبیه‌سازی، کاربران سامانه شاهد، هواپیما را از محل فرودگاه (شکل ۵۴) و کاربران سامانه اصلی، هواپیما را در حالی که از حدود غرب در حال نزدیک شدن بود (شکل ۵۵) مشاهده کردند.

شکل ۵۴- سمت هدف در سامانه پدافندی شاهد در شبیه‌سازی در حالتی که خطای تنظیم شمال وجود نداشته است.

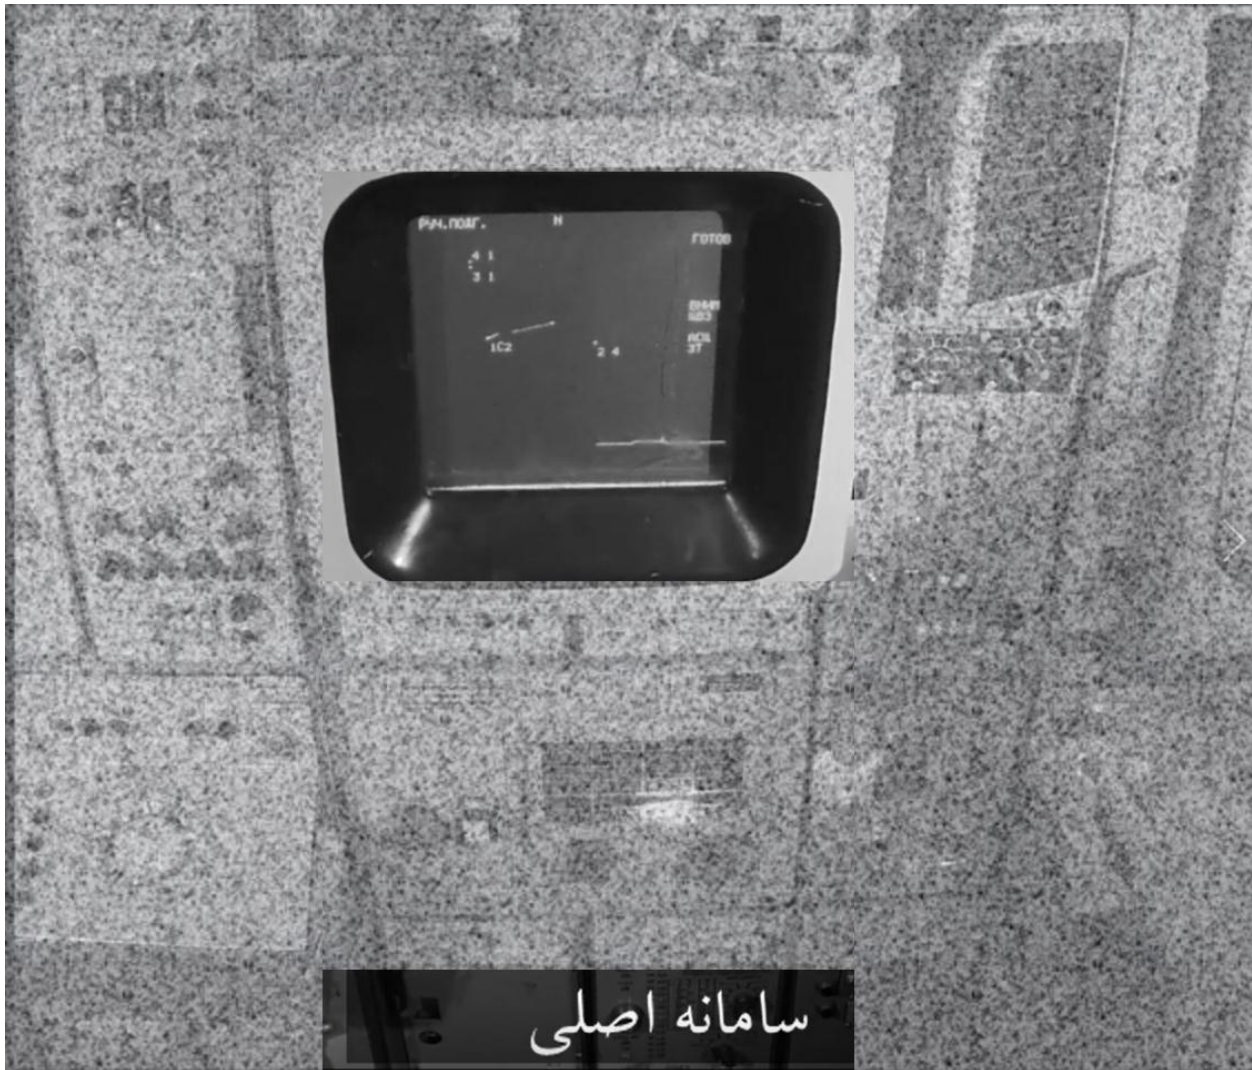
در محلی که سامانه پدافندی شلیک کننده قرار داشت دو سامانه قرار داده شدند. در یک سامانه که به عنوان سامانه اصلی شناخته می‌شد، خطای تنظیم شمال نیز همانند سامانه شلیک کننده تکرار شد و در سامانه‌ای دیگر که سامانه شاهد شناخته می‌شد، خطای تنظیم شمال اصلاح گردید.

شکل ۵۵- سمت هدف در سامانه پدافندی مشابه اصلی در شبیه‌سازی در حالی که خطای تنظیم شمال تکرار شده بود.

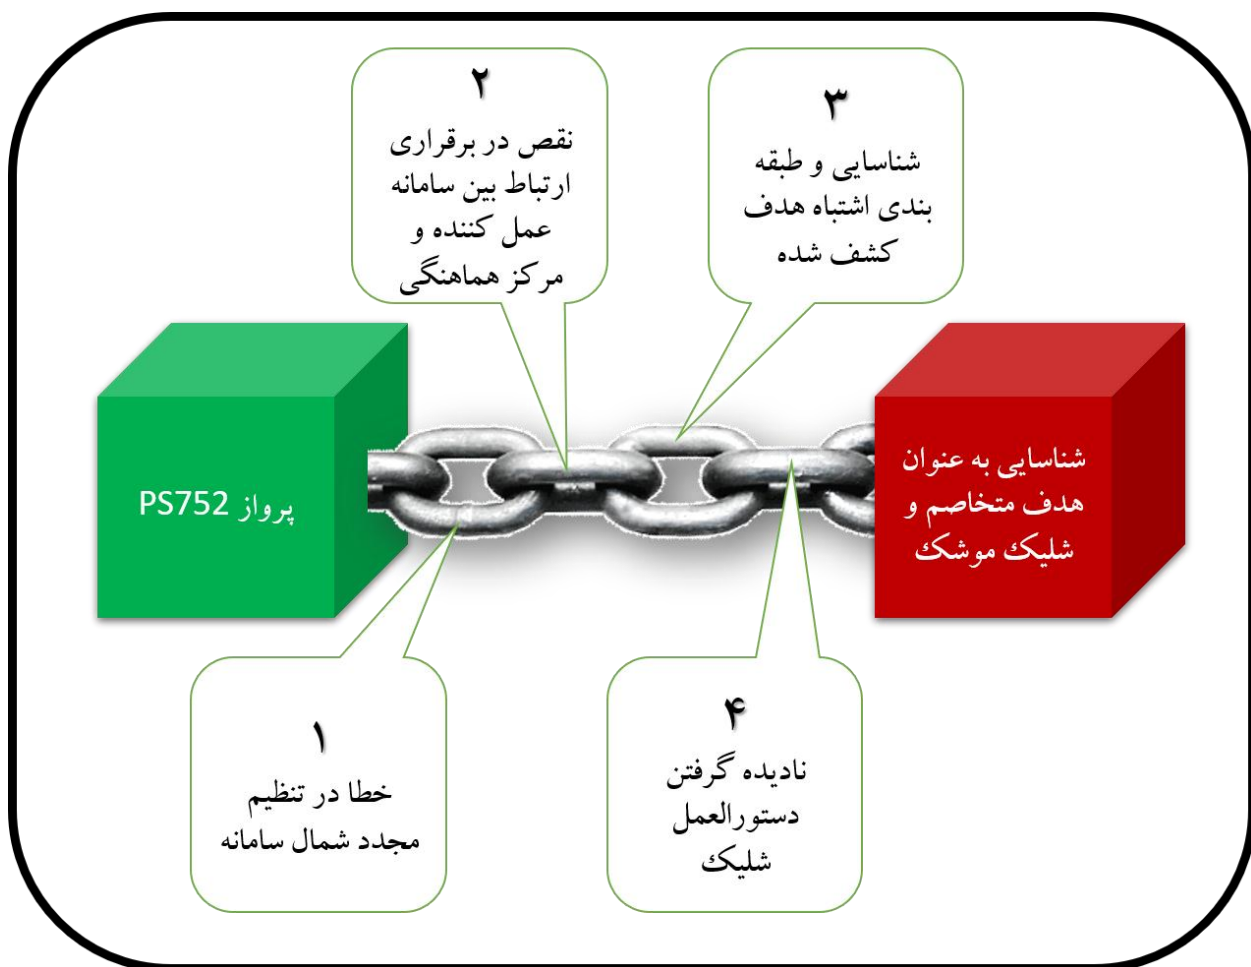
مشخصات این هدف به مرکز اعلام شده بود، لیکن این پیام به مرکز مبادله نمی‌شود و کاربر بدون دریافت پاسخ و یا دستور از مرکز، هدف را متخاصم تشخیص داده و بر خلاف رویه پیش‌بینی شده، اقدام به شلیک موشک به سمت هواپیما می‌نماید.

شکل ۵۶- زنجیره خطای شکل گرفته که منجر به شلیک موشک به سمت پرواز PS752 شد.

وجود این مخاطره و احتمال شکل گرفتن چنین زنجیره‌ای پیش‌بینی نشده بود و در محاسبات ریسک مربوط به شناسایی اشتباه در نظر گرفته نشده بود.
