دفتر بررسی سوانح و حوادث هوایی

بررسی سانحه پرواز PS752

گزارش نهایی

شماره پرونده:	A981018URPSR
نوع رویداد:	سانحه
تاریخ رخداد:	۱۳۹۸/۱۰/۱۸
محل رخداد:	جمهوری اسلامی ایران- نزدیک فرودگاه بین‌المللی امام خمینی (ره) (OIIE)
نوع هواپیما:	بوئینگ ۷۳۷ سری ۸۰۰
علامت ثبت:	UR-PSR
تاریخ صدور:	۱۳۹۹/۱۲/۲۵

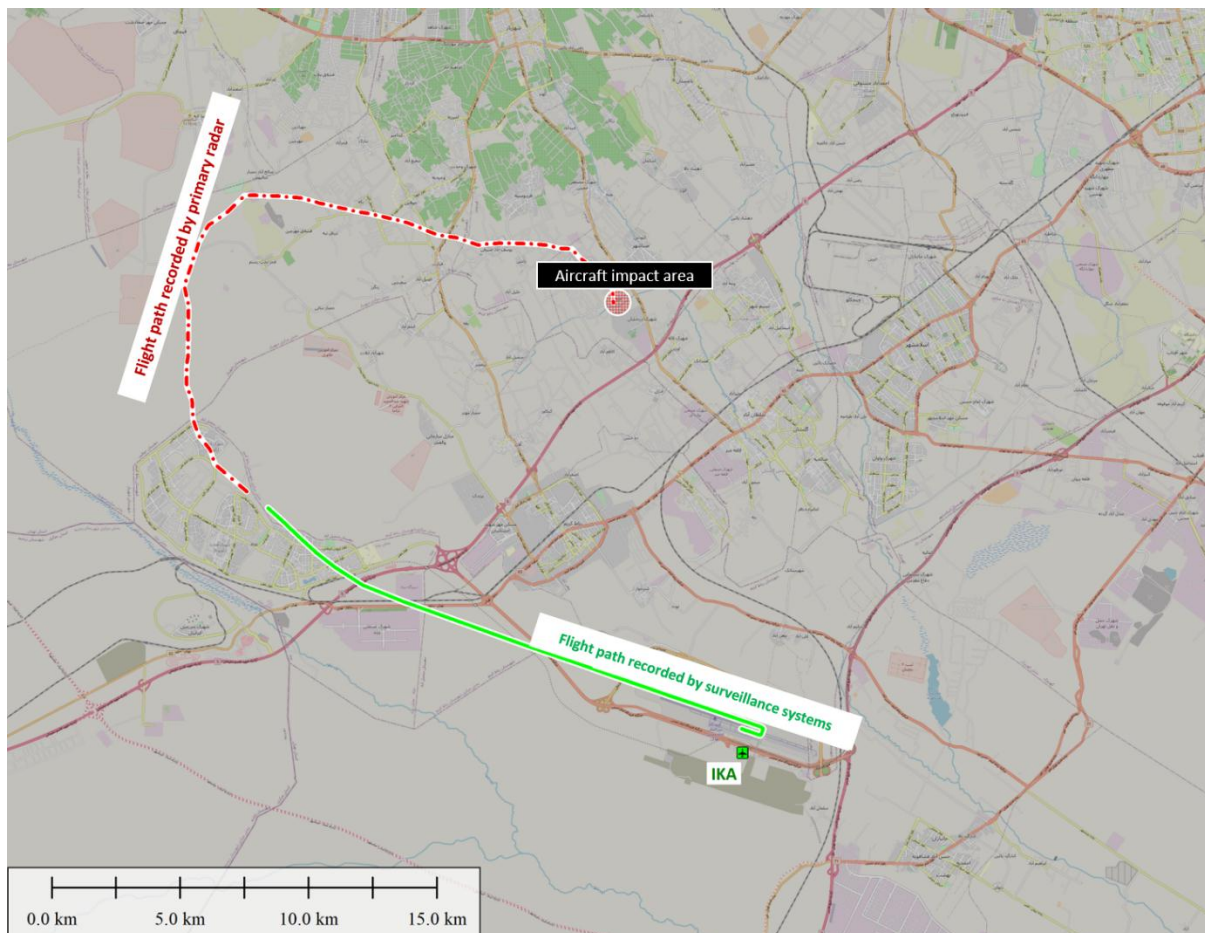
After takeoff, the aircraft continued flying on the planned path, but at position $35^{\circ}29'29.79''\text{N}$ $50^{\circ}57'13.43''\text{E}$, the ATC transponder signals and FDR recording terminated, shortly afterwards the aircraft began turning to the right and losing height². While already on fire (based on observations of eyewitnesses and recorded videos), the aircraft crashed into the ground at position $35^{\circ}33'45.63''\text{N}$ $51^{\circ}6'11.21''\text{E}$ and exploded. Figure 6 depicts the flight trajectory.

Figure 6- Flight PS752 trajectory

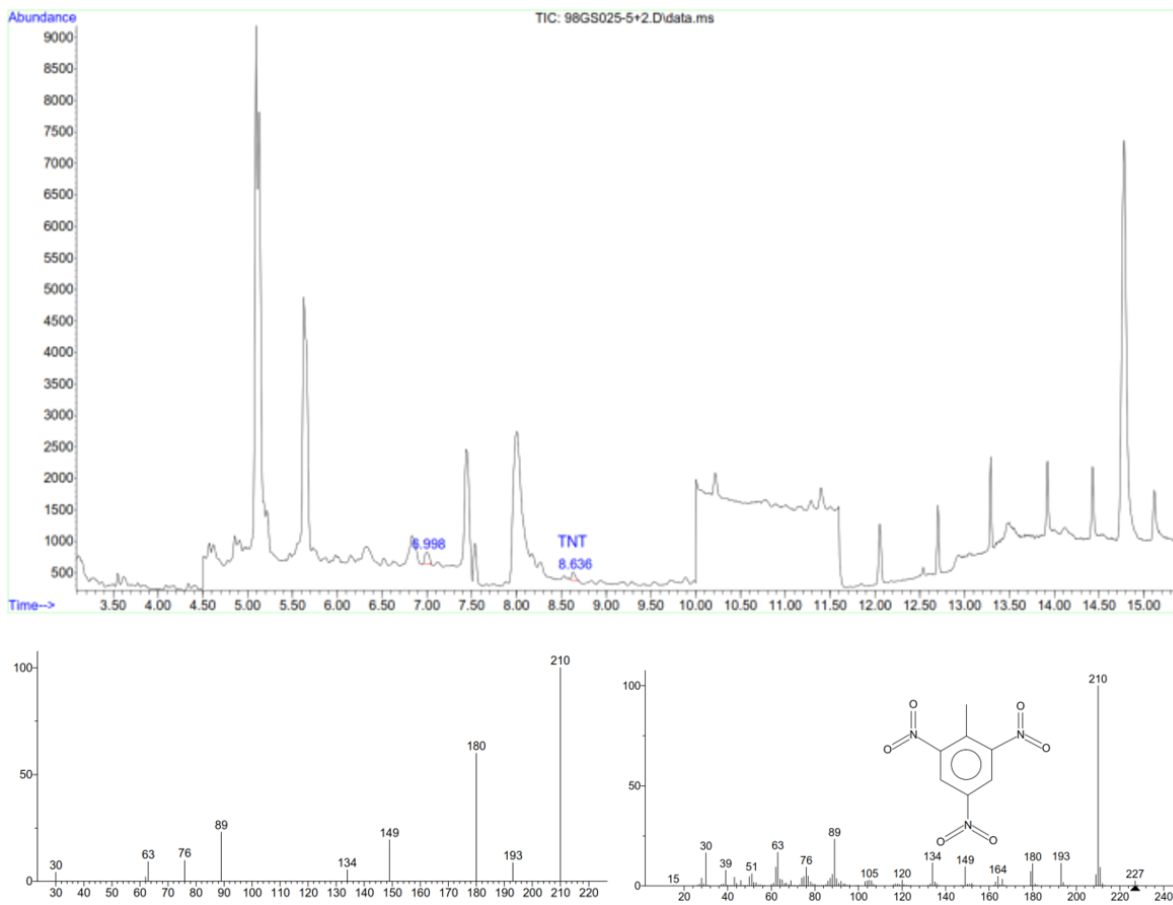
Based on the results yielded through GC/Mass chemical analysis, the existence of Trinitrotoluene (TNT) explosives with a chemical formula C₇H₅N₃O₆ was confirmed in the aircraft wing skin, which was found before the crash site. (Figure 27)

Figure 28- Gas chromatography–mass spectrometry; GC-MS, of aircraft wing skin piece

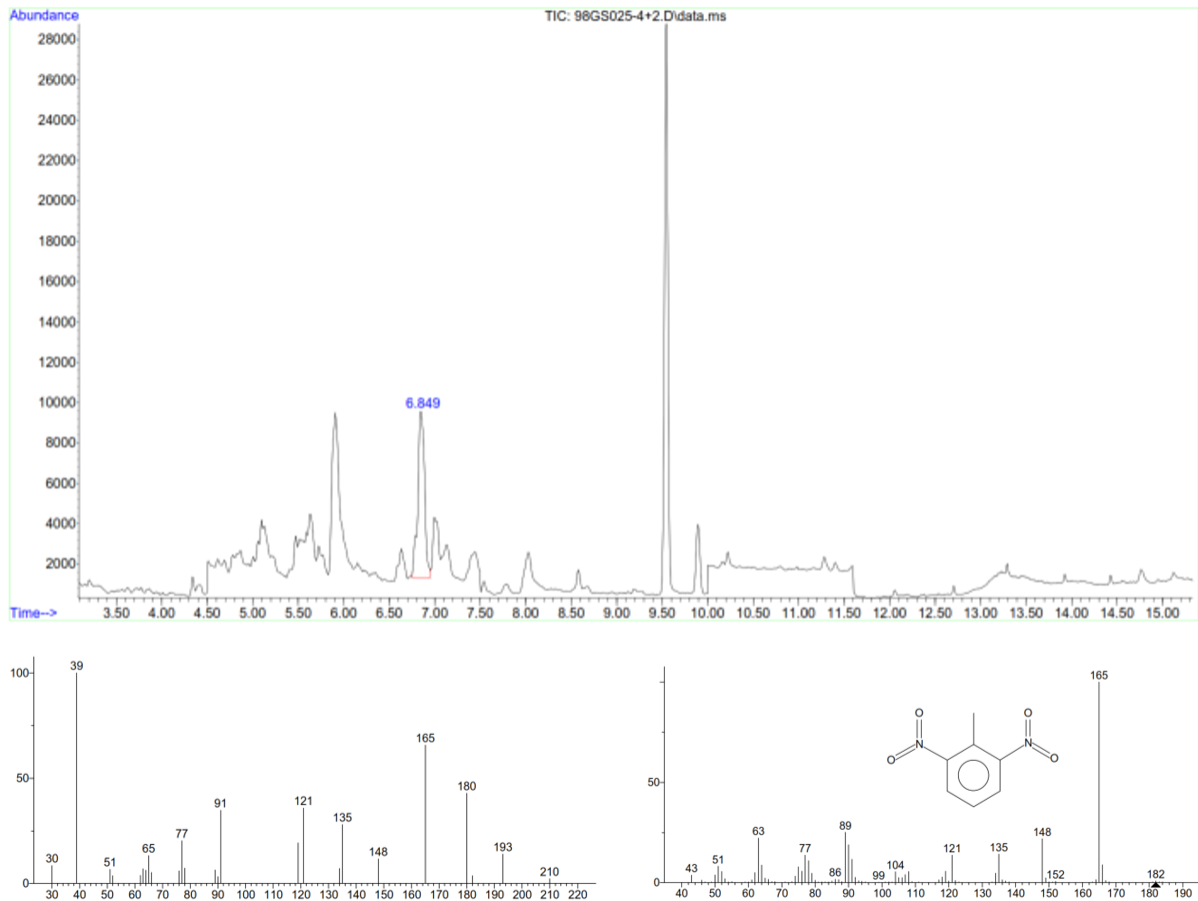
By sampling the air conditioning system and the two ELT pieces of the aircraft (Figure 29) and performing gas-chromatographic-mass spectrometry on each of the parts, the presence of negligible amounts of Dinitrotoluene (DNT) with the chemical formula $C_7H_6N_2O_4$ was proven.

Figure 30- The GC-MS of the ELT and heat exchanger

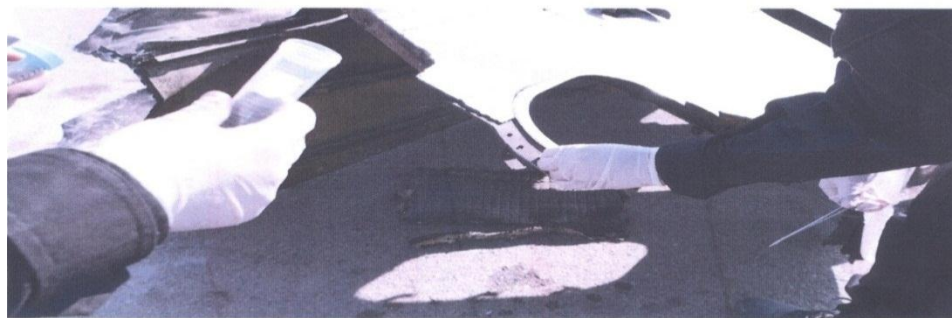
According to the spectrometry obtained from the interior part of the aircraft cabin window (as shown in Figure 31), the presence of explosive Trinitrotoluene (TNT) was detected (Figure 32).

Figure 31- The interior of part of the aircraft cabin window pieces on which the explosive test was done

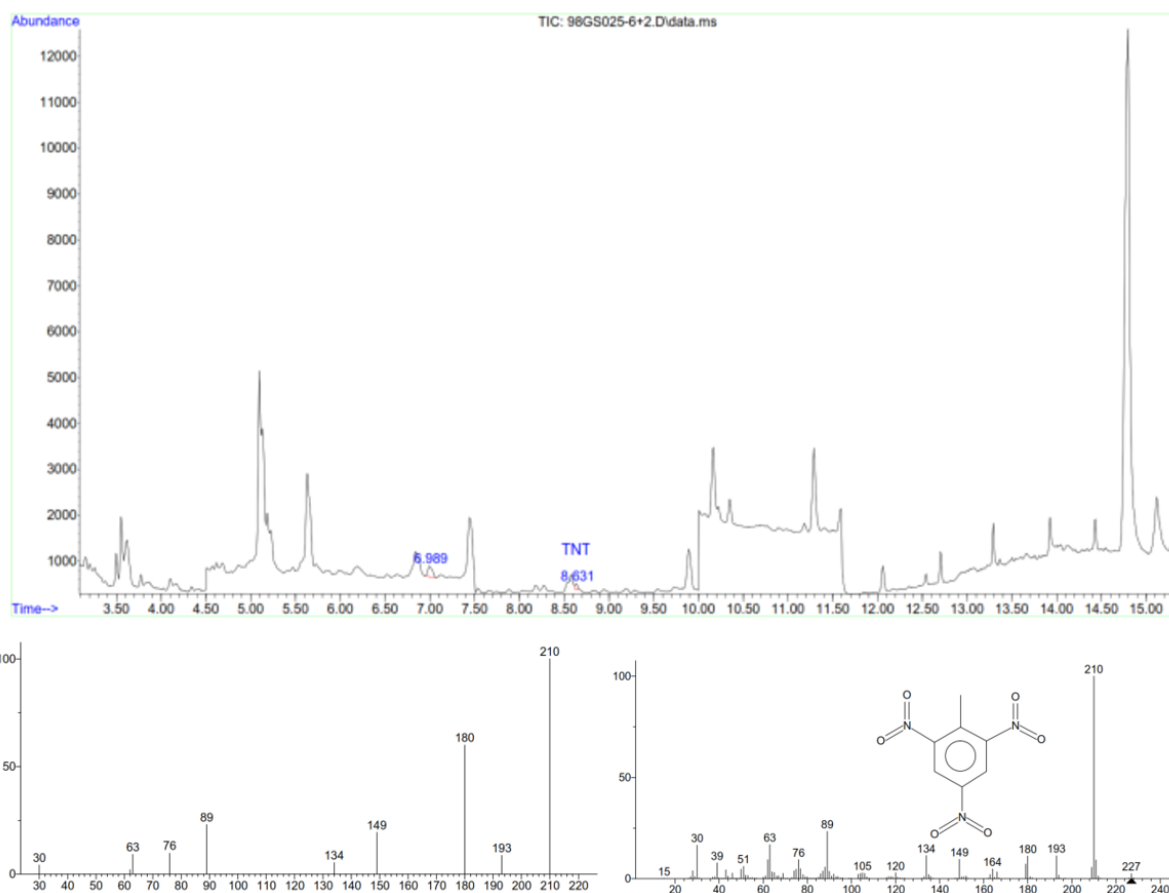
Figure 32- The GC/Mass test result from the interior of part of the aircraft cabin window Pieces

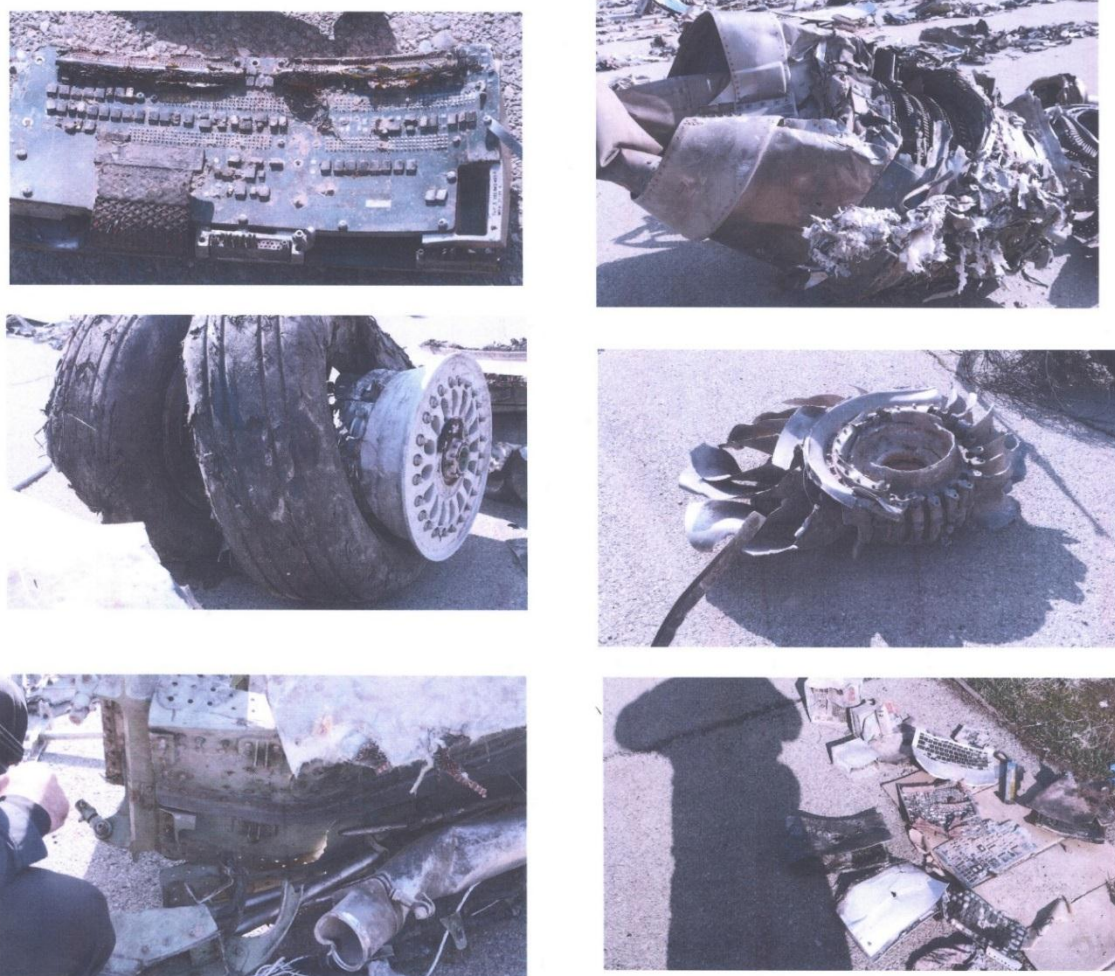
It should be noted that no explosive contamination was observed in the samples taken from the engines and other aircraft pieces or the objects inside the passenger cabin (Figure 33).

Figure 33 -Some of the aircraft parts free from explosives

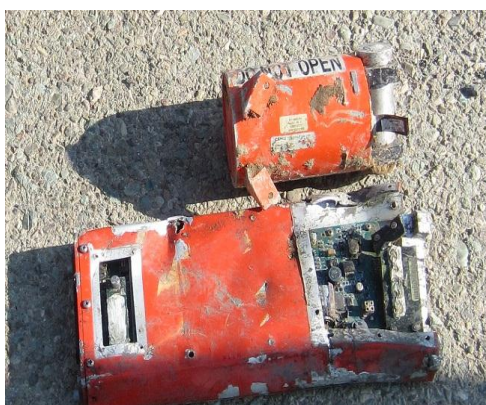
Damage to CVR had been more serious, whose main memory (CSMU) was detached due to the impact severity. The condition of these recorders indicated that the CVR and FDR had not been exposed to the fire in the aircraft, and after the ground impact, they were damaged or exposed to fire. (Figure 35 and Figure 36)

Figure 36- CVR physical appearance after the crash

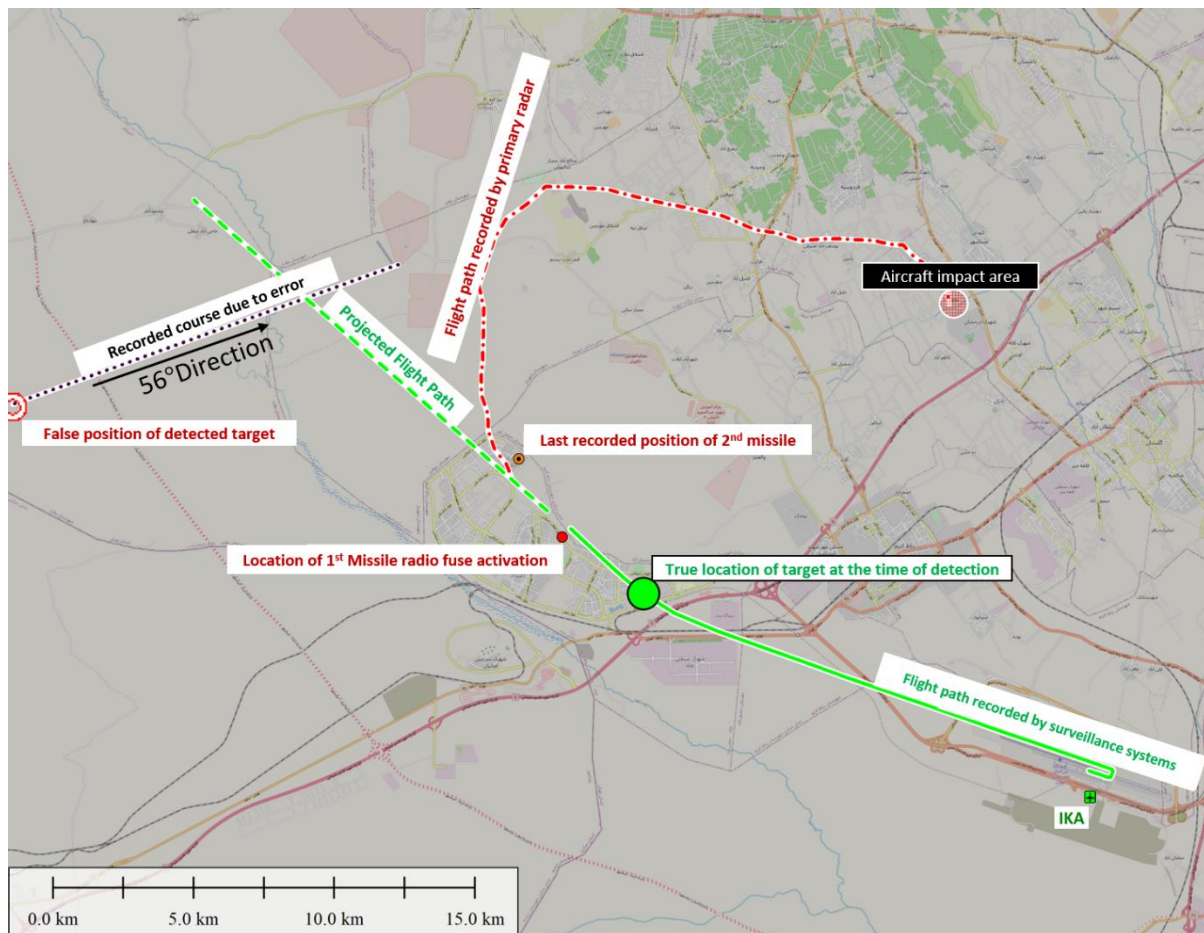
At 06:15:22, the last communication between the second missile and the defense system was recorded in a place close to the aircraft route. After that, the defense system showed a message indicating the strike had failed, with the aircraft clearing from the radar lock-on after some time.

Figure 41- The location of key events in missile launch

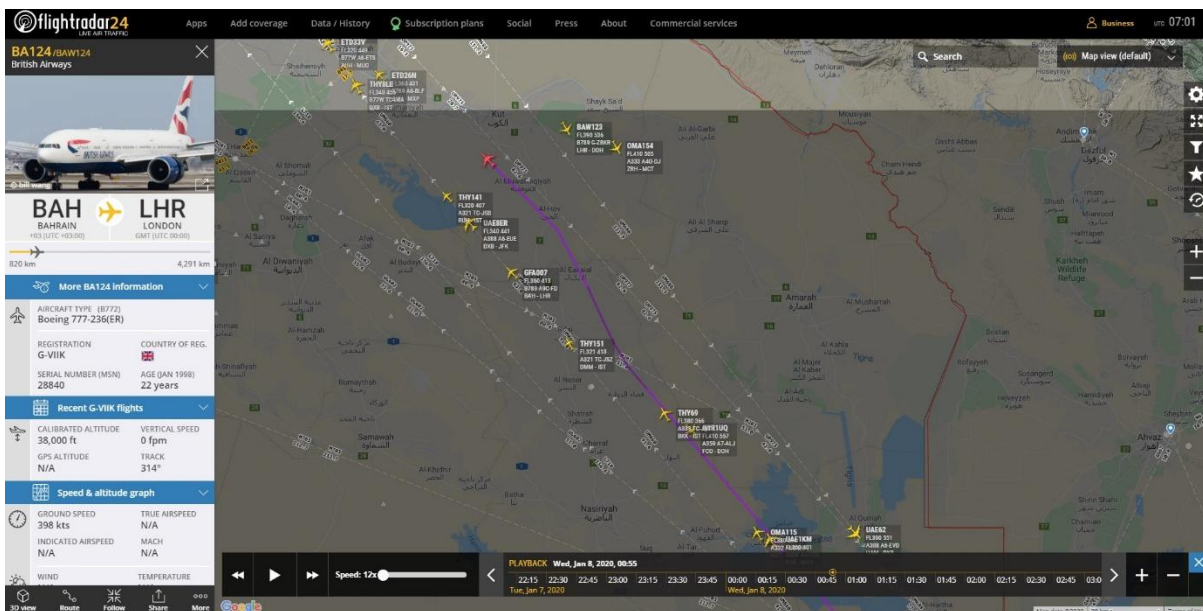
Figure 53- BAW124 whose entry into the Iranian airspace was denied due to the suspension of traffic exchange between Tehran and Baghdad FIR

It was also observed that at 04:11 Iraq ACC requested their counterpart in Iran to accept the entry of British Airways fight BAW124 into the Iranian airspace. This was, however, denied due to the restriction imposed on the traffic exchange between the two countries -Iran and Iraq (Figure 53). Such a negative response was in line with the planned preventive measures.

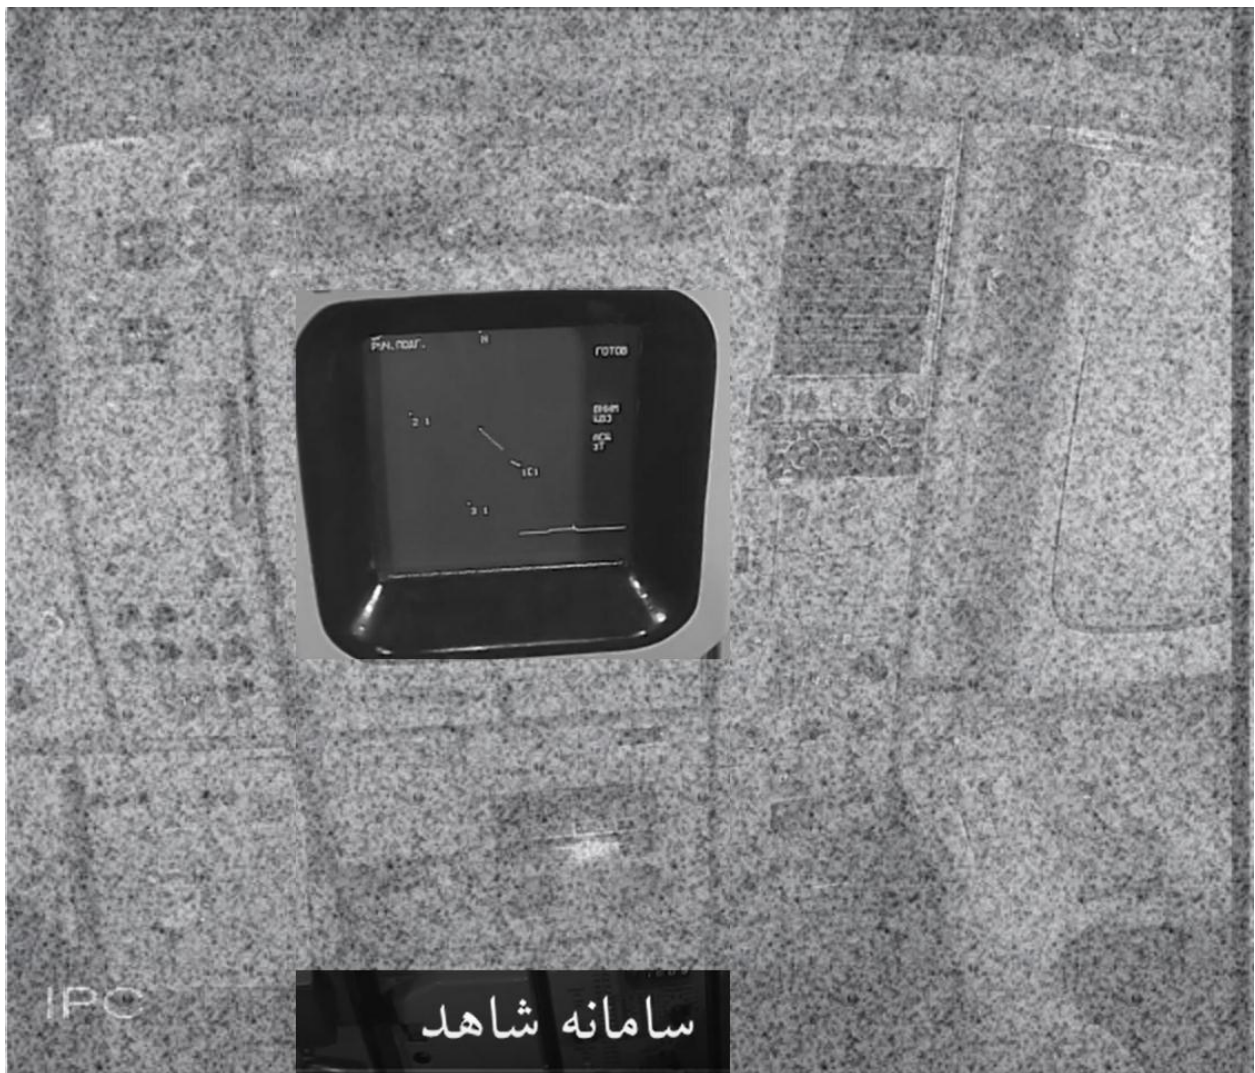
Figure 54- The target direction in the reference ADU in the simulation with correct North alignment

The simulation also indicated that the aircraft flight operation did not play a role in the occurrence of the error made by the air defense unit operator. In the two times of simulation, the reference unit operators detected the aircraft from the IKA direction (Figure 54), while the main unit operators detected it approaching from the western area (Figure 55).

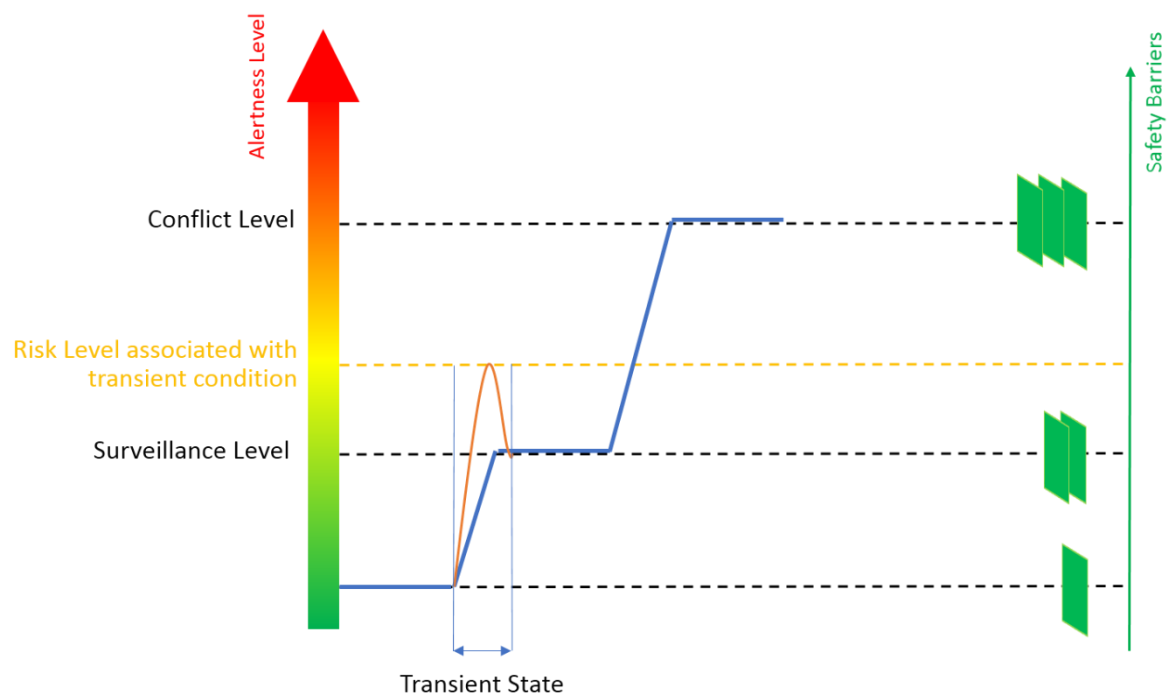
Figure 57- Alertness levels and risk in transient condition

In PS752 accident case, taking into account that the prevailing conditions rapidly changed at about 02:00, it is likely that at the time of the accident, the transition time was not finished yet and this transient condition contributed to human errors and the existing hazards within the whole system.
